## near rads cleaned

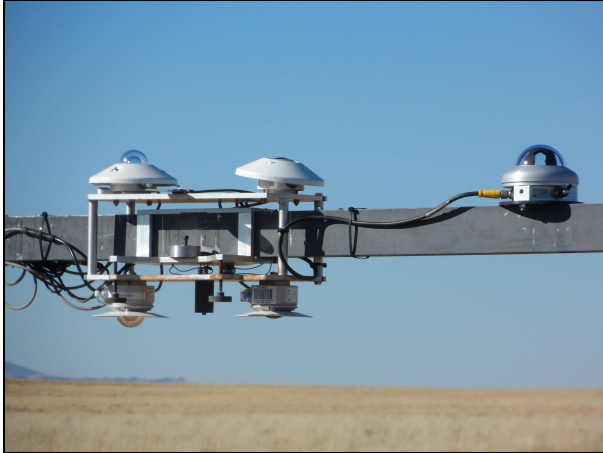
Went to near to get some insight (pun intended) into why Rsw.in and Rsw.global.in don't agree nearly as well as in SOAS. Didn't solve this problem, but did find that the shield on Rlw.in was cocked -- perhaps even in the field of view of the sensor -- I took a photo. Tom thinks he may have loosened it when he last changed the dessicant (more than a week ago), though he didn't notice it being off when he cleaned 2 days ago. The logical conclusion is that it was loose and recent winds skewed it more (though winds haven't been <that> high in the last 2 days...)

Also decided to clean the radiometers while I was there, since I could imagine a film of dust on the SPN1, though the tissue didn't come away dirty. There were spider webs around. At most, the change of either Rsw.in or Rsw.global was 3 W/m<sup>2</sup> -- not enough to explain the large differences we've seen.

Cleaning done about 15:30, though I was standing near the radiometers starting about 15:15.
