## Replaced surface met sensor at sodar-RASS

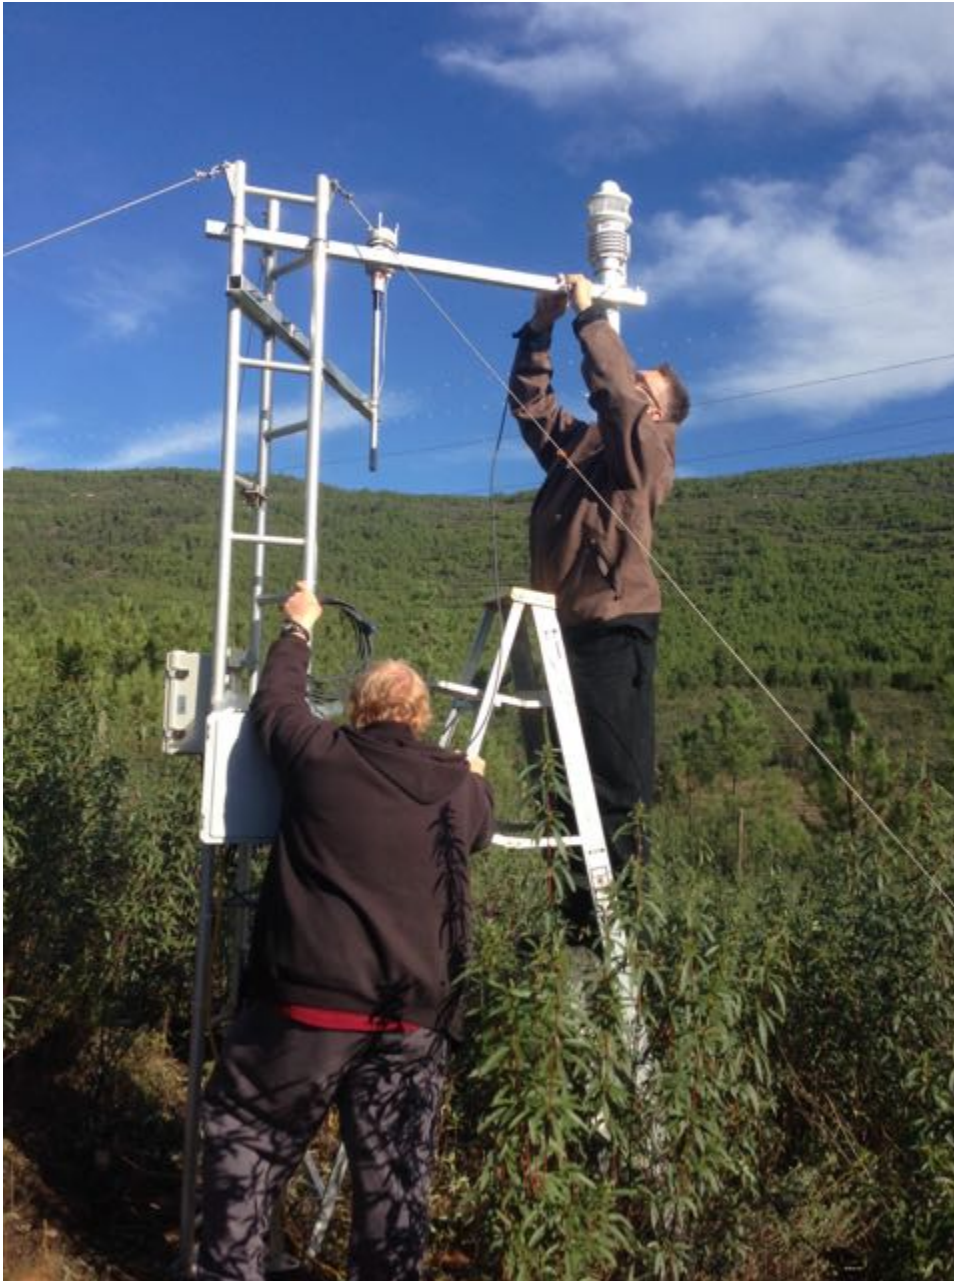
The WXT surface met sensor stopped reporting for an as yet undetermined reason. Attempted to replace with another WXT on the same DSM port but that gave the same sensor not found error, suggesting a DSM problem. To replace it we installed a Lufft ws700 adjacent to the WXT and that appears to be recognised by the DSM and it's data is being ingested (from around 11UTC, 17 Dec).
