# Sonic at LC site

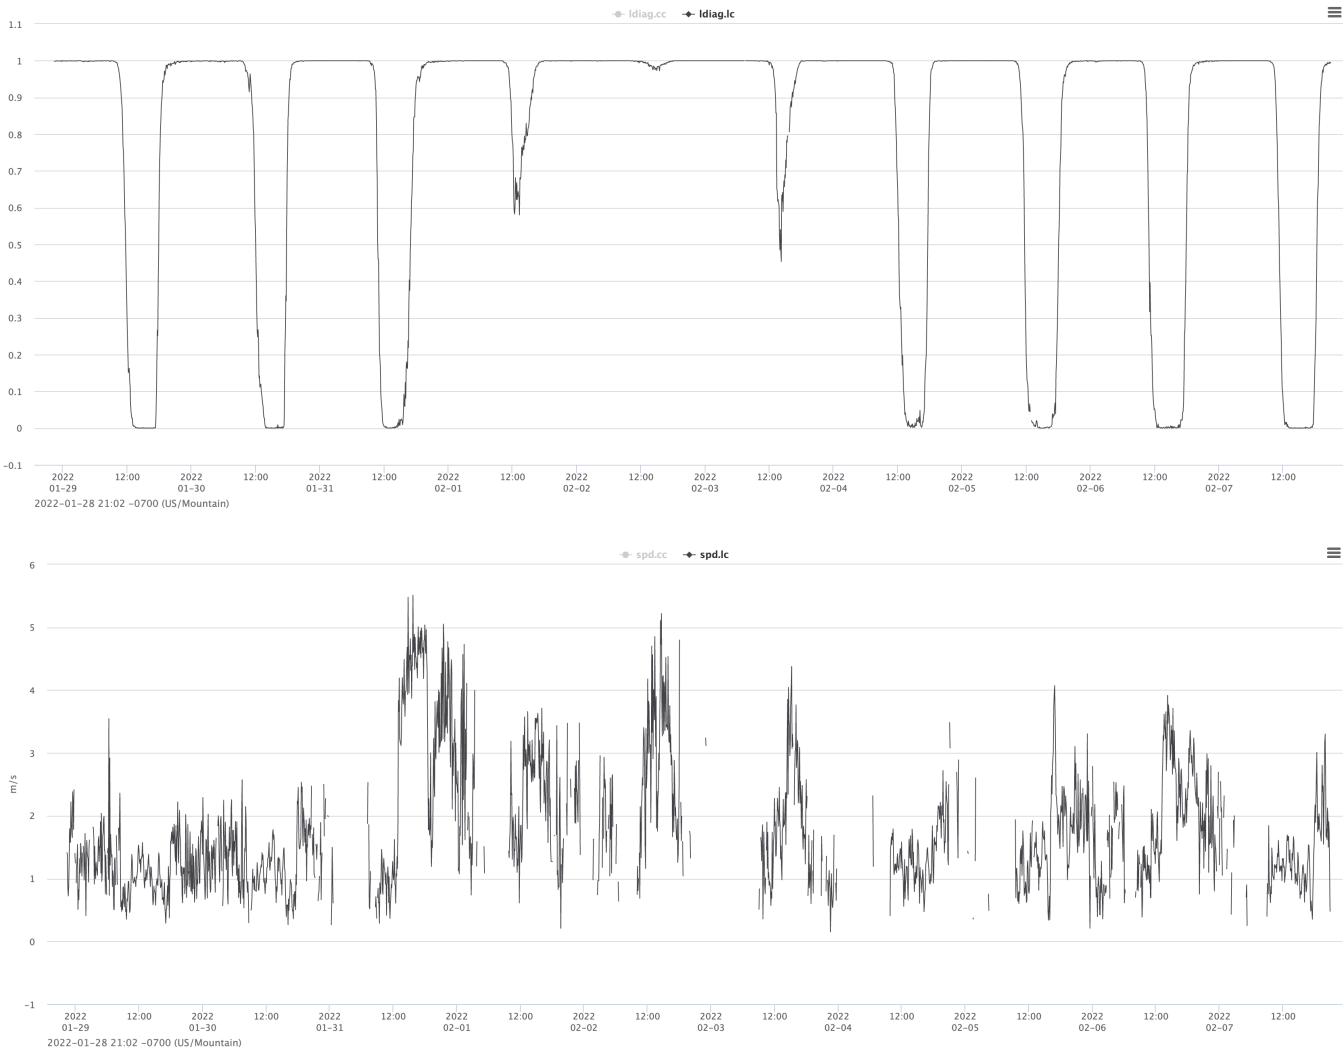
Over the last ~7 days we've noticed that the sonic at LC has been intermittent during the overnight hours. During these periods we're seeing an ldiag=1, although the sonic does still report values sporadically. As it turns out, the pattern of ldiag=1 from roughly 8 pm to 9 am has been consistent throughout the project, however the missing data started just within the last week or so.

In looking at the DSM dashboard today, I found diagbits=0, 1 and 5 at various times while ldiag=1. I haven't looked at past data to see if this pattern has been consistent. According to the EC-100 manual these represent "amplitude is too low", "amplitude is too high", and "sonic head calibration signature error", respectively.

It's pretty clear that this is not an icing/obstruction issue, so the best course of action may be swapping out the sonic. Since we do not have a spare, Steve has suggested swapping out the EC-100 box to see if that helps. John and Jacquie will try this in the next couple of days.
