# Ops 2/9

## Site LC

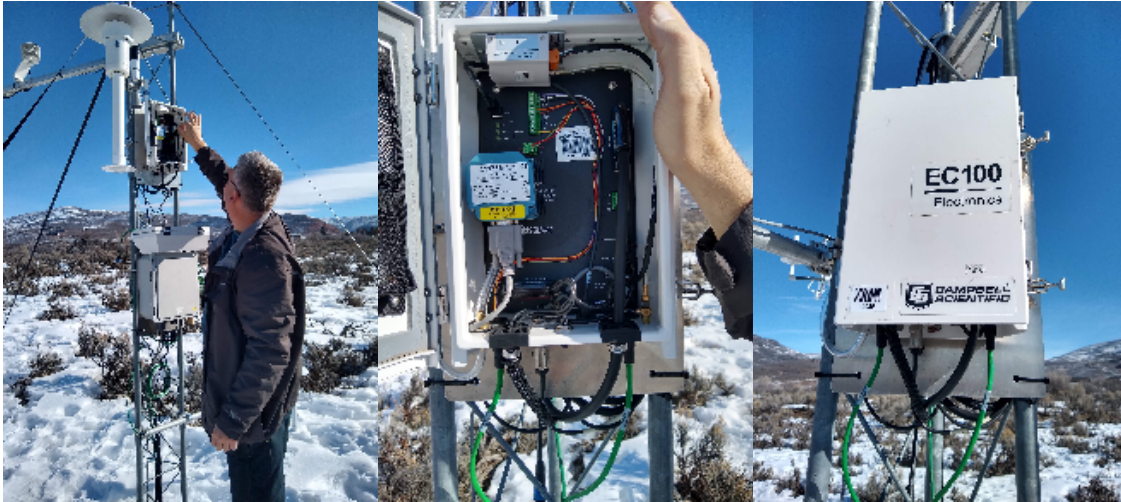
- We replaced the EC100 ~ 1030AM but the sonic light was still blinking red here and there. So it looks like the EC100 didn't fix the intermittent bad data.
