01 May 2022

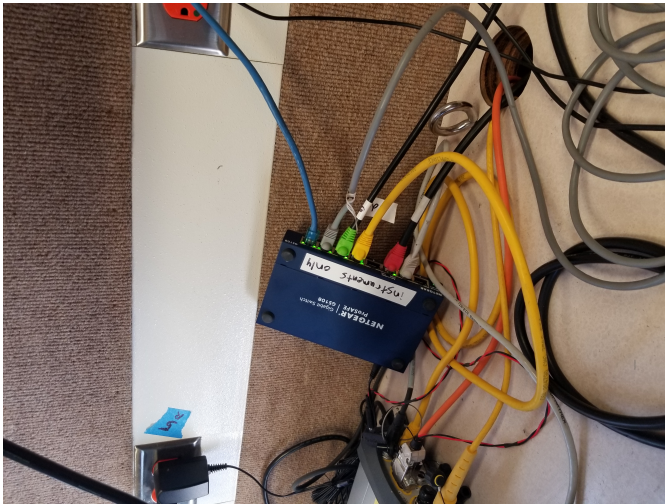
I also notice a message window on the lidar laptop saying it (the laptop/client?) had lost communication with the server. I noticed that some of the cables plugged into the Ethernet switch were not sitting in their jacks square due to lateral strain from the relatively inflexible network cable coming in from outside (I believe it was the DSM Ethernet cable). A similar problem was seen at ISS1 in CFACT (reported in [Ops 2/15](#)) and I suspected the same issue. I pulled the Ethernet switch off the wall and set it on the countertop surface in a manner that there is no lateral forces on the Ethernet cables plugging into the switch (image below). I also re-plugged all the Ethernet cables into the switch. Shortly thereafter, the communication error on the lidar laptop went away. I may revisit the site tomorrow and move the two construction screws that hold the switch onto the wall over to be above the hole in the countertop where the rigid Ethernet cables come in from the outside, to eliminate any cross force on the plugs.

Ethernet switch on the countertop after re-plugging connections to remove lateral forces. The black Ethernet cables with the red plug is an outdoor cable (used for the DSM, I believe) and was pulling sideways on the switch and may have been causing connectivity issues. I may remount the switch on the wall above the hole in the countertop to alleviate the issue and get the switch back off the countertop surface.
