## 16m TRH acting up

TRH at 16 meters has had sporadic problems since Apr 8 07:00 MDT.

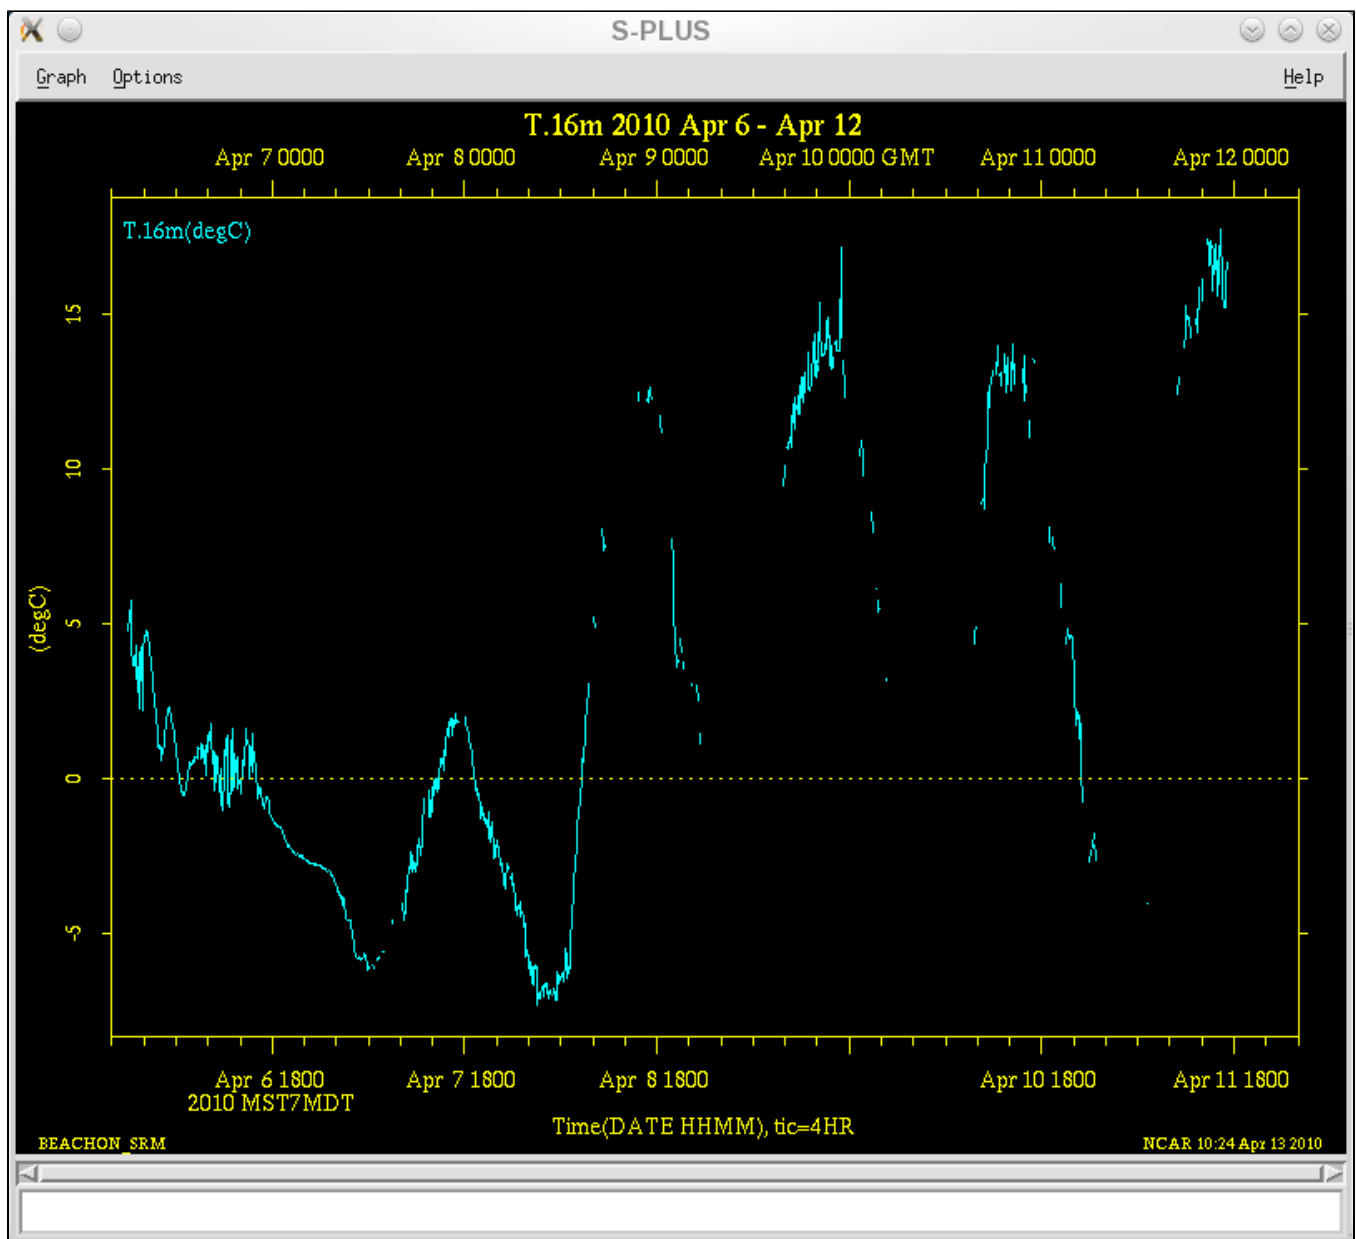
Over Apr 10,11 and 12 it seems to come alive in the warmest part of the day, (at temps over 10C) and then fails as the temp falls in the evening. See plot below.

Here is a dump of some recent data (times in GMT).  
Looks like the processor is getting reset, printing out its calibration  
information when it boots. Perhaps the power is dropping out?  
Corroded connection?
