# DSM interrupt loads

Gordon, Nov 29

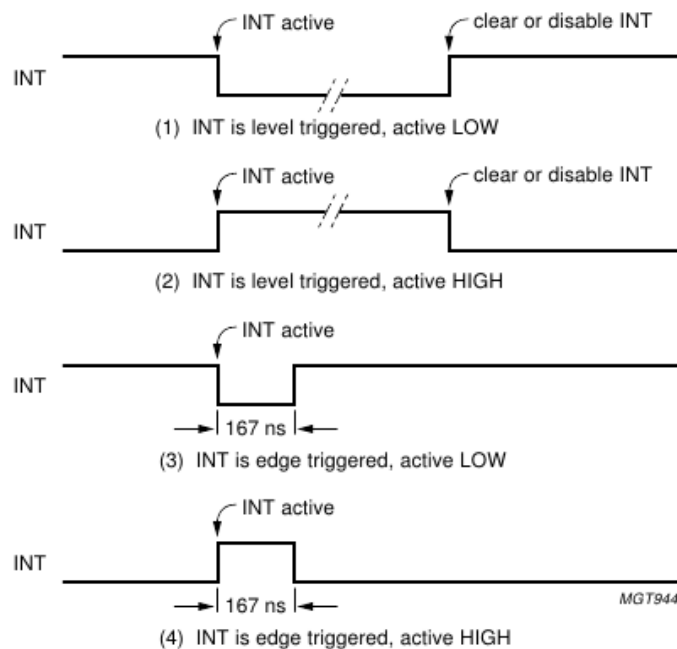
Fig 20. Interrupt pin operating modes.

The current isp116x driver is configured for level triggered (int\_edge\_triggered=0, default) and active high (int\_act-high=1) interrupts. However, the setting for the corresponding GPIO interrupt is IORESOURCE\_IRQ\_HIGHEDGE. This might mean the interrupt is not being acknowledged correctly.

Figure 20 shows these four interrupt configuration modes. They are programmable through register settings, which are also used to disable or enable the signals.
