DSM interrupt loads

Gordon, Nov 29

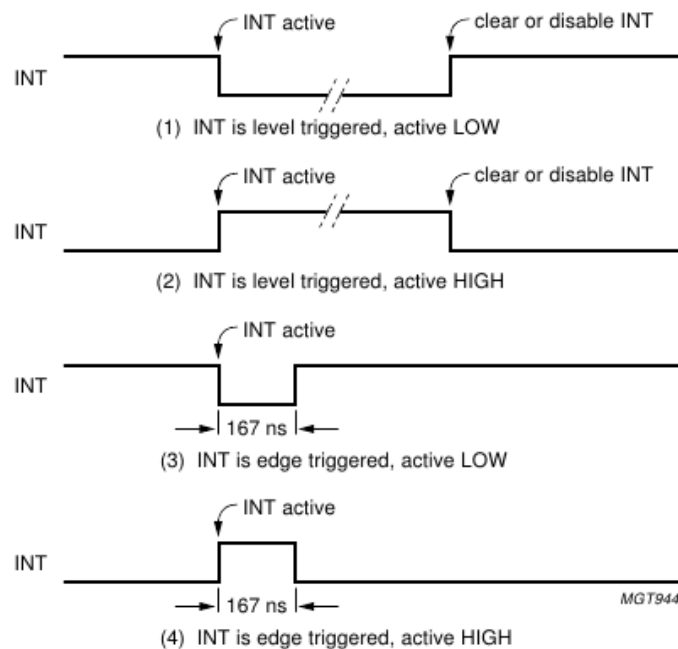
Fig 20. Interrupt pin operating modes.

The current isp116x driver is configured for level triggered (int_edge_triggered=0, default) and active high (int_act-high=1) interrupts. However, the setting for the corresponding GPIO interrupt is IORESOURCE_IRQ_HIGHEDGE. This might mean the interrupt is not being acknowledged correctly.

Figure 20 shows these four interrupt configuration modes. They are programmable through register settings, which are also used to disable or enable the signals.
