# All Log Contents

[Flux tower anchor positions](#)

[Photos of dinged tower](#)

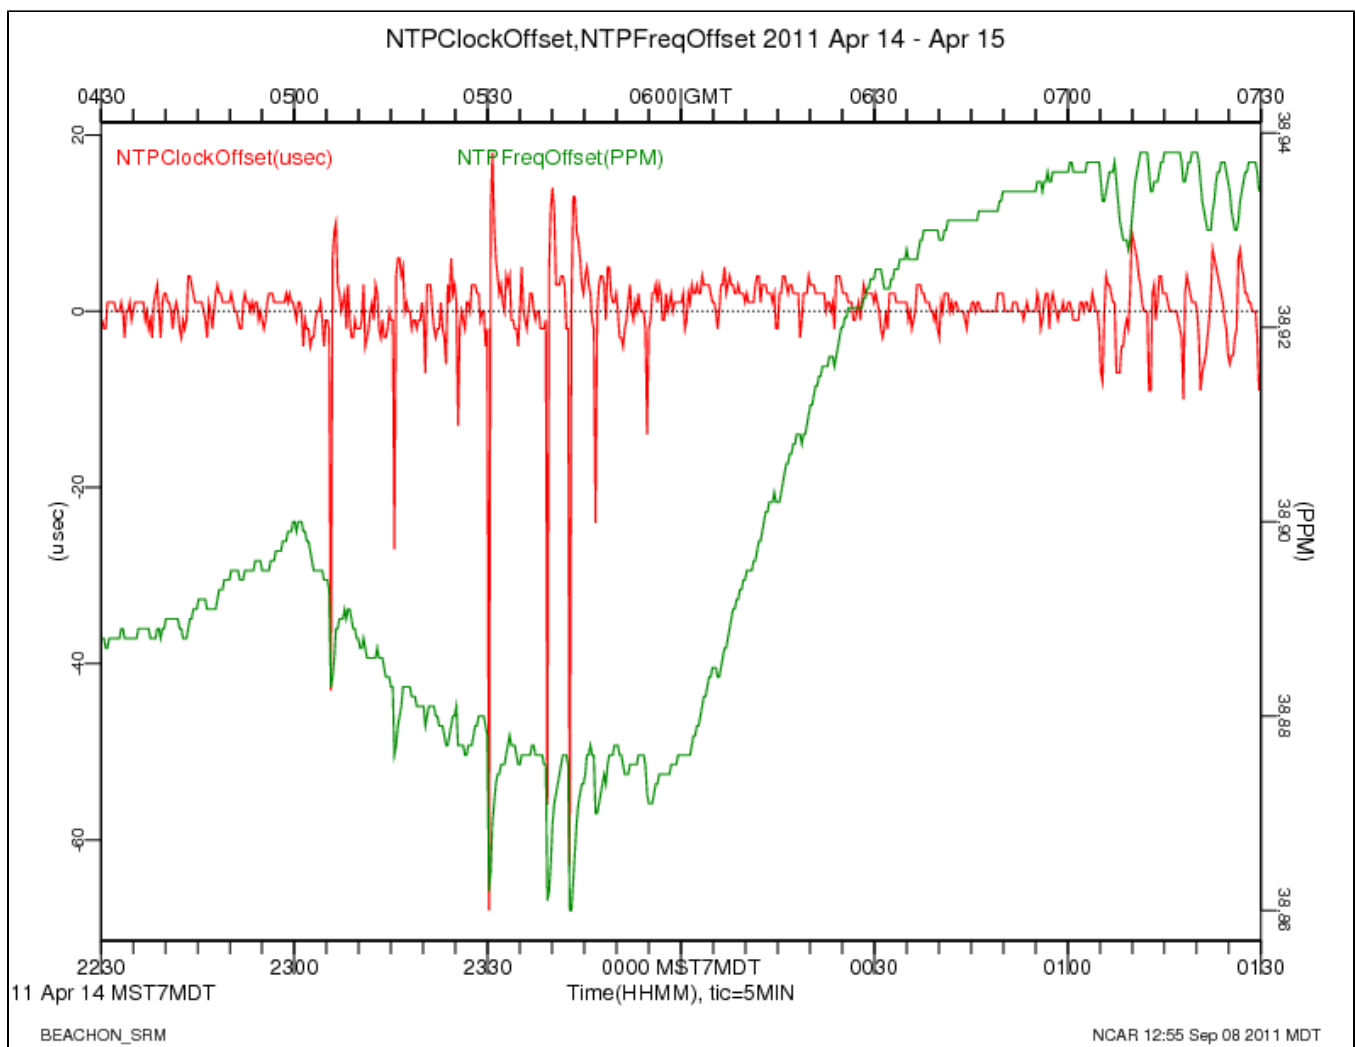
The periodic spikes in GPSdiff\_max up to 1 second that occur at 23:00 local time and last about an hour, are simultaneous with the network transfer of the day's data files from the DSM to the RAL server. These suggest that increased sample buffering and latency is happening at these times, which needs to be investigated and improved.

A close-up of the file transfer on April 14, 23:00, plotted below, shows several events where NTPClockOffset first has a negative spike, indicating that NTP has determined that the GPS clock is behind the system clock and starts to slow down the system clock. These down spikes appear to be due to a delay in the response to a PPS interrupt. The interrupt latency appears to be short lived, because the NTPClockOffset becomes positive, and the system clock is re-adjusted. The April 14 transfer is shown in this plot:

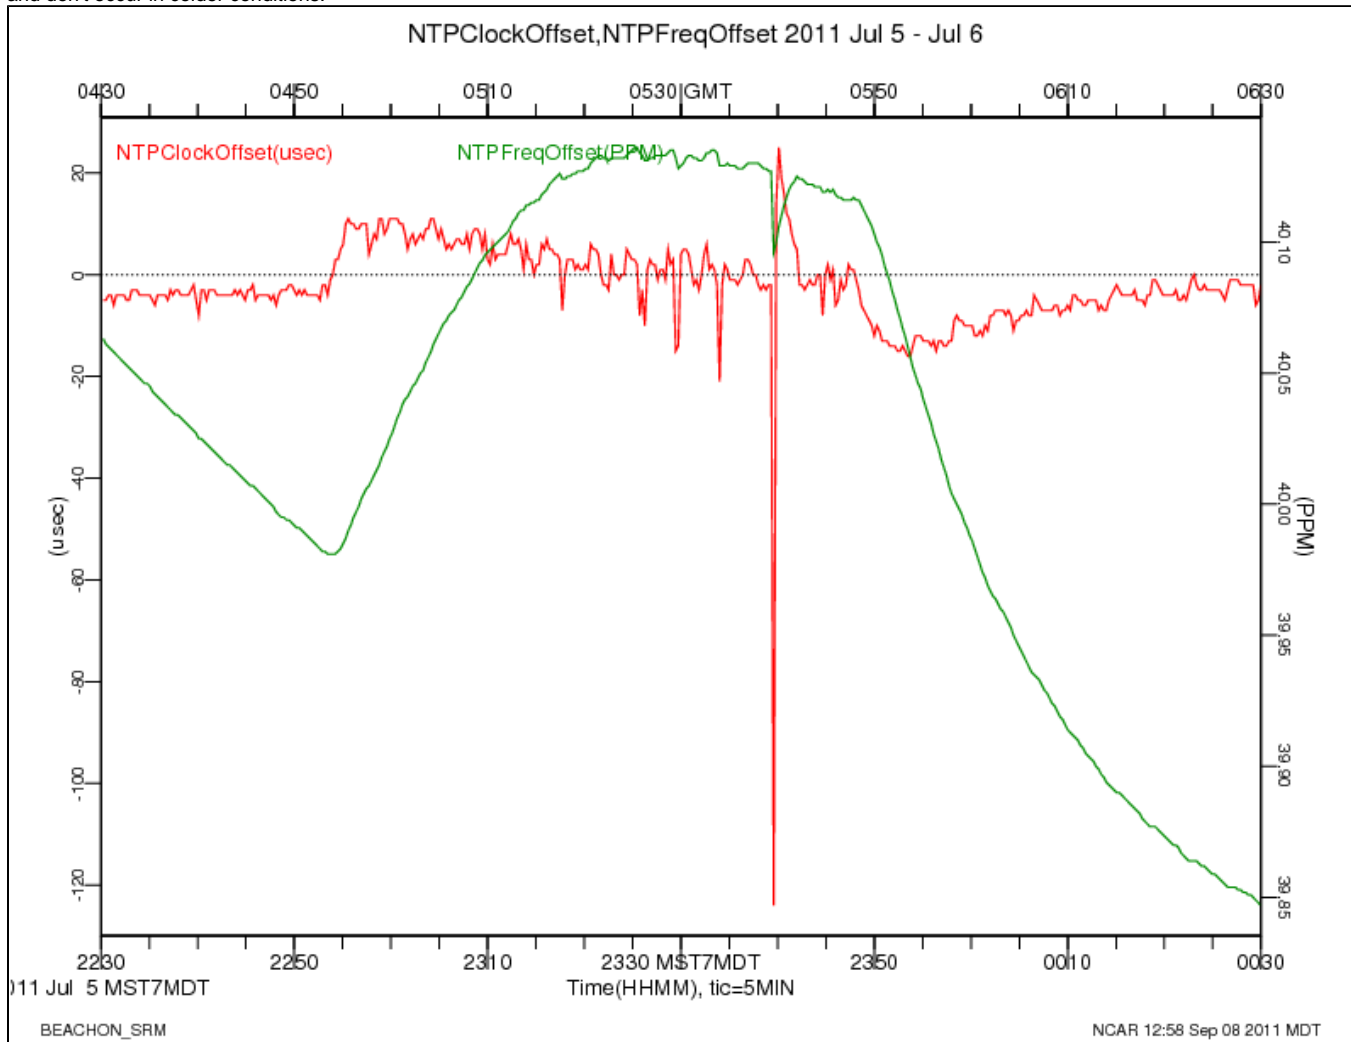
In July, the clock behaviour during the file transfer is similar, but the initial increase in NTPClockOffset and a rising slope in NTPFreqOffset might be due to increased heating of the system clock oscillator, due to increased CPU load during the file transfers. Wild conjecture? After a quick scan of the web plots of 5 minute averages, I think these positive bumps in NTPFreqOffset seem to occur during file transfers when the outside air temperatures are above 0 C, and don't occur in colder conditions.

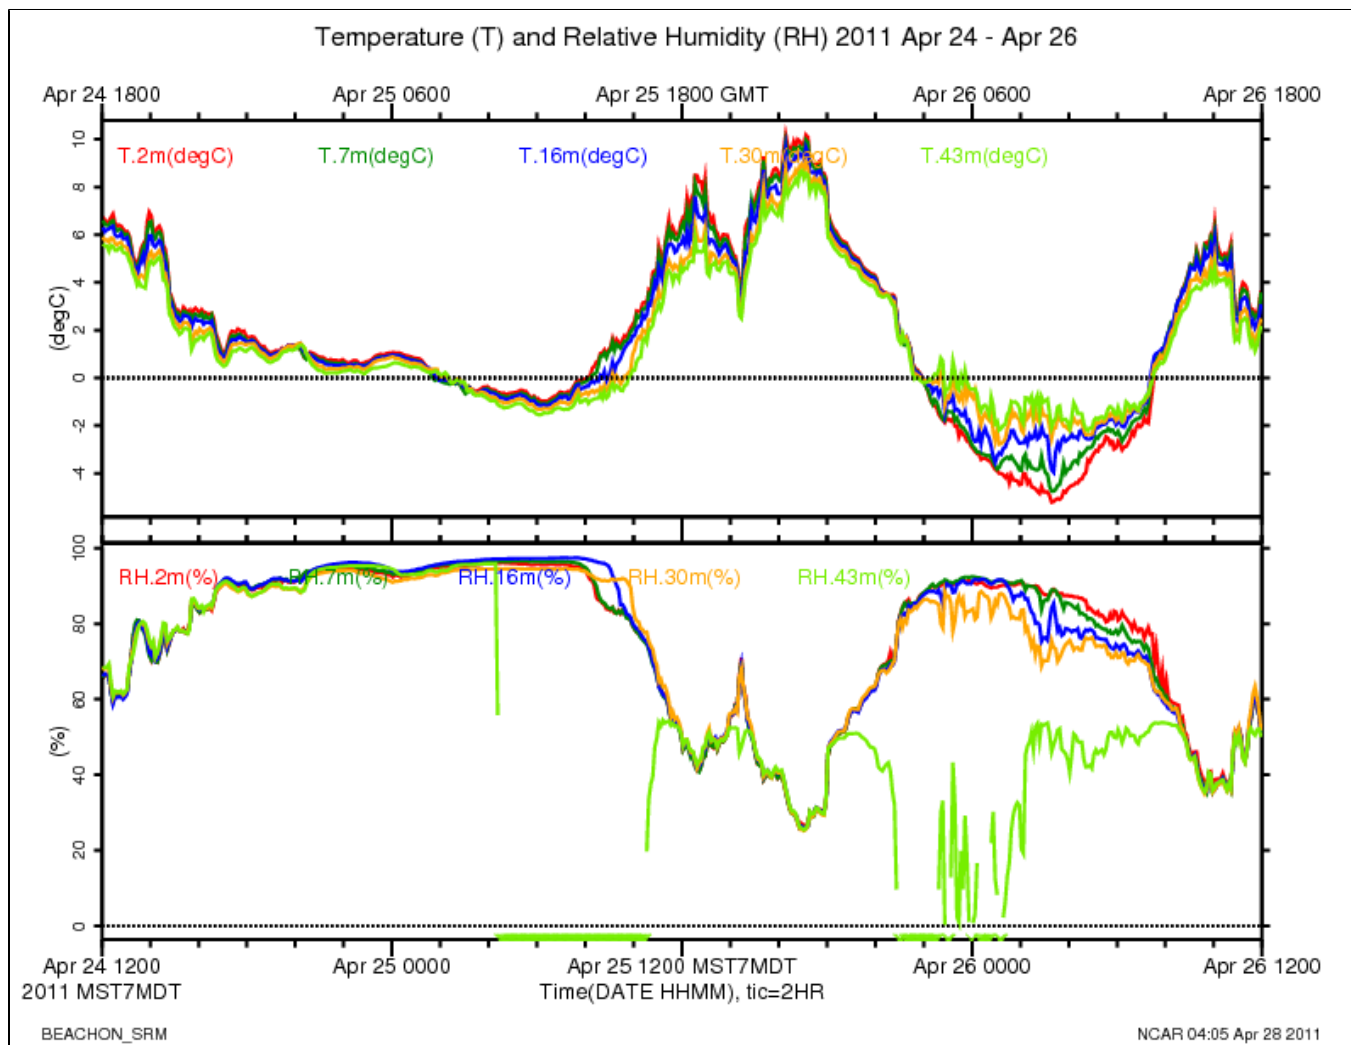
RH at 43m has been bad for a while. Looking back through the plots, looks like it failed the night of Apr 25 during a period of near 100% RH.
