All Log Contents

[Flux tower anchor positions](#)

[Photos of dinged tower](#)

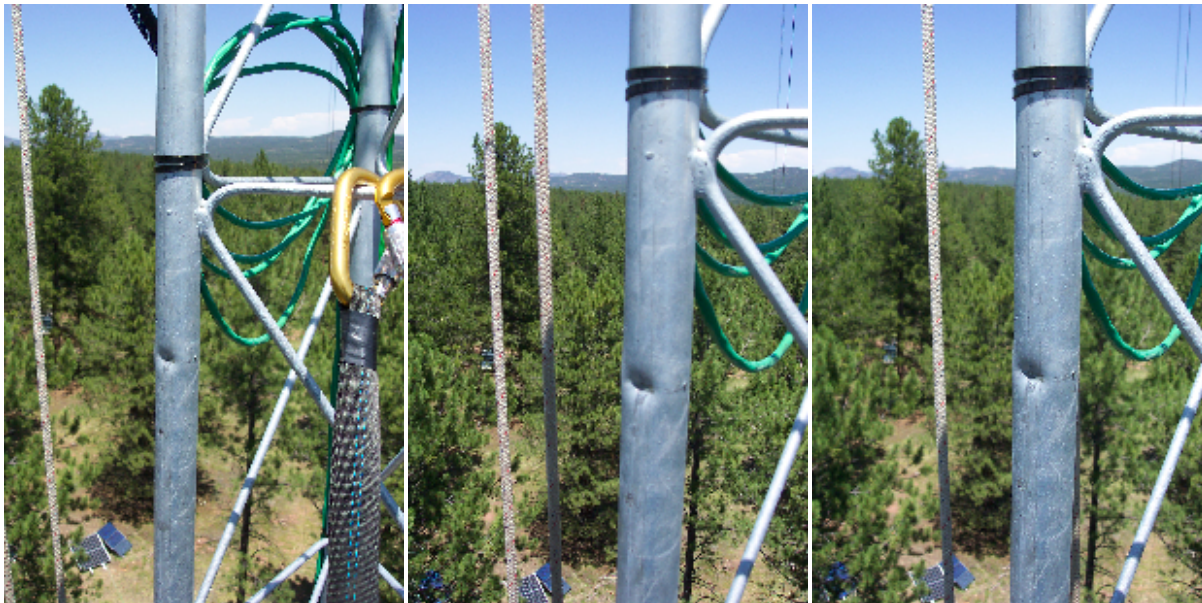
Photos of Tower damage

Found these photos of the damage to the tower. The tower was fixed on Nov 6, 2009, <https://wiki.ucar.edu/x/DhAFaw>

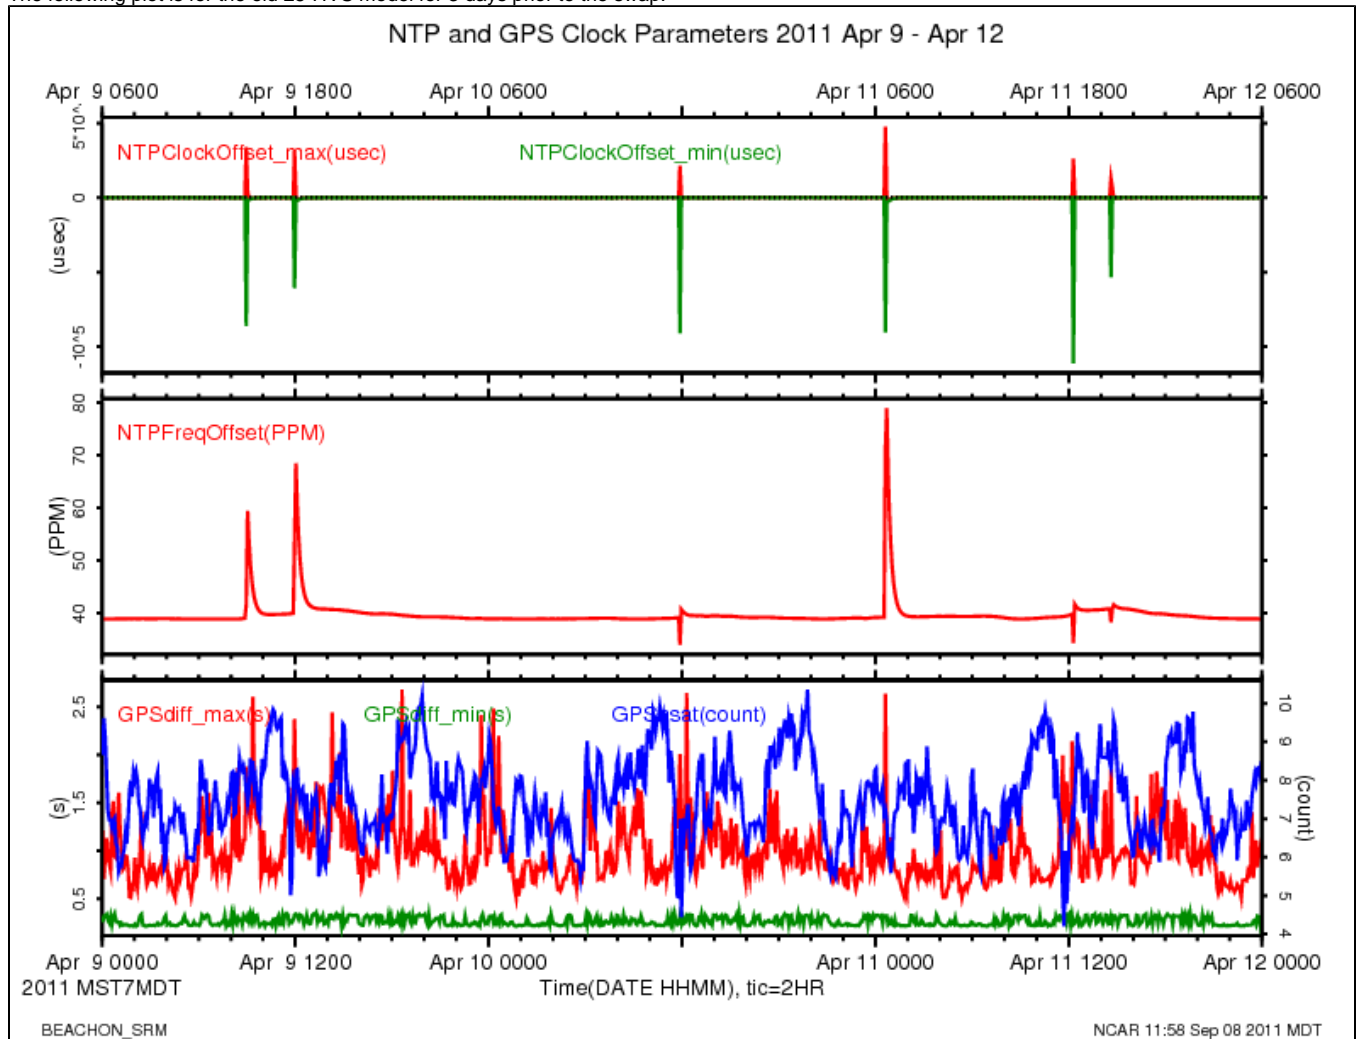
The following plot is for the old 25-HVS model for 3 days prior to the swap:

The NTPClockOffset shows spikes between -100000 to 50000 microseconds during this period, which is much worse than expected for a GPS/NTP reference clock. The spikes in NTPClockOffset are simultaneous with positive jumps in GPSdiff_max, up to as much as 2.5 seconds. These events seem to happen when the number of tracked satellites changes, which indicates that internal processing lags in the 25-HVS cause it to report late, causing large values of GPSdiff. The extent of this effect on the timing of the PPS signal is unknown.

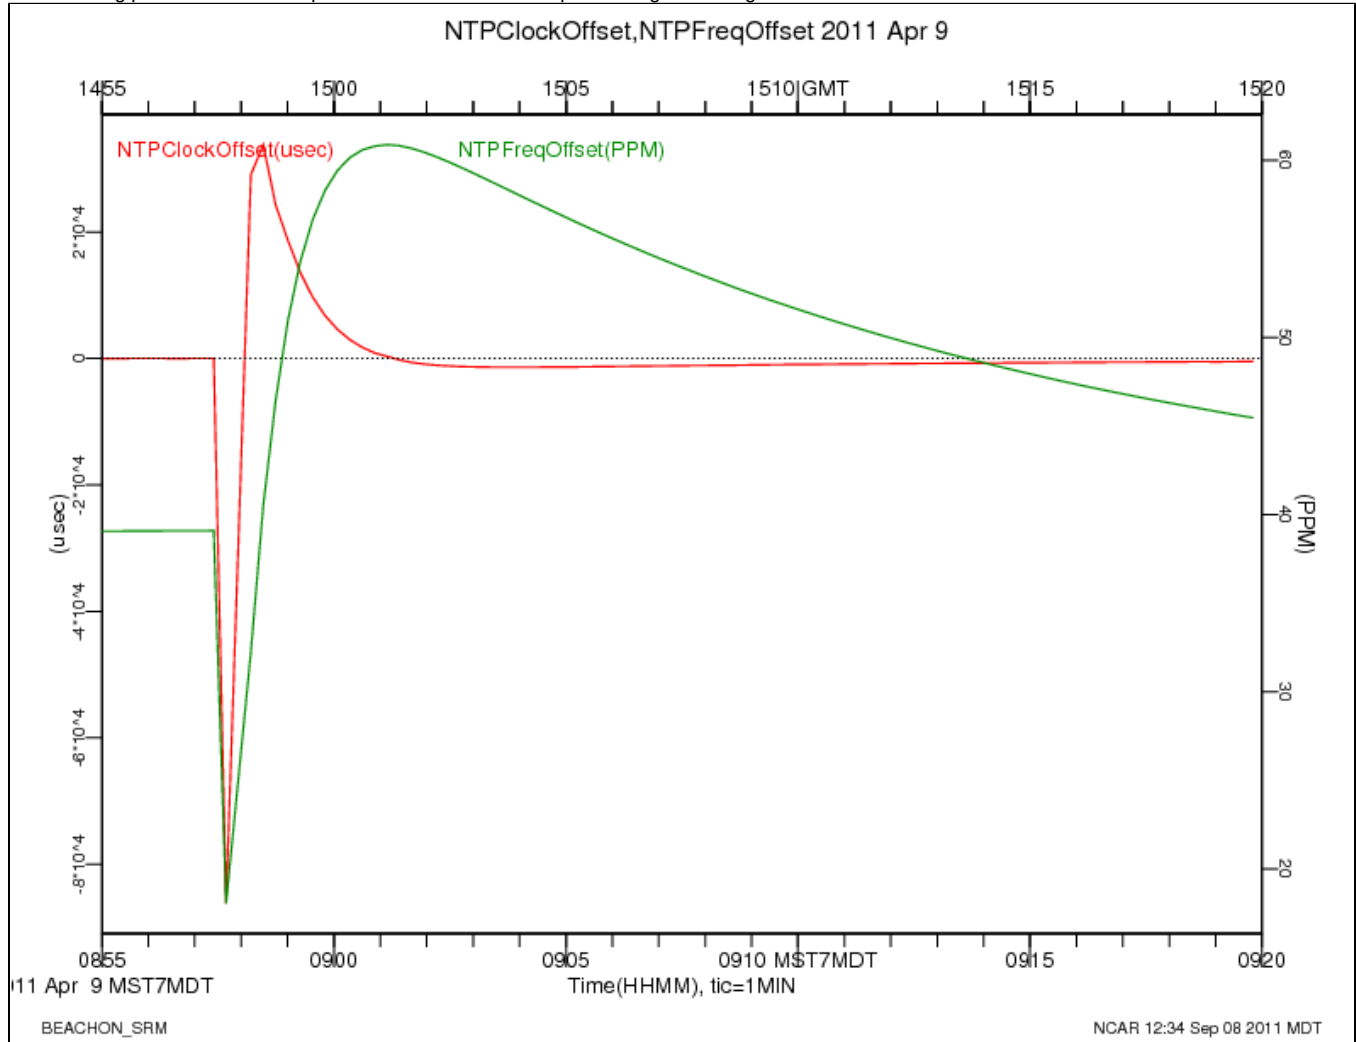
The following plot shows a close up of one of the clock offset spikes using un-averaged data:

The sudden downward jump in NTPClockOffset causes NTP to think that the GPS clock is earlier than the system clock. NTP starts to correct for the offset by slowing down the system clock, as seen in the negative values for NTPFreqOffset. When the GPS recovers from its delayed reporting, NTP then sees positive values for NTPClockOffset and adjusts the system clock ahead.

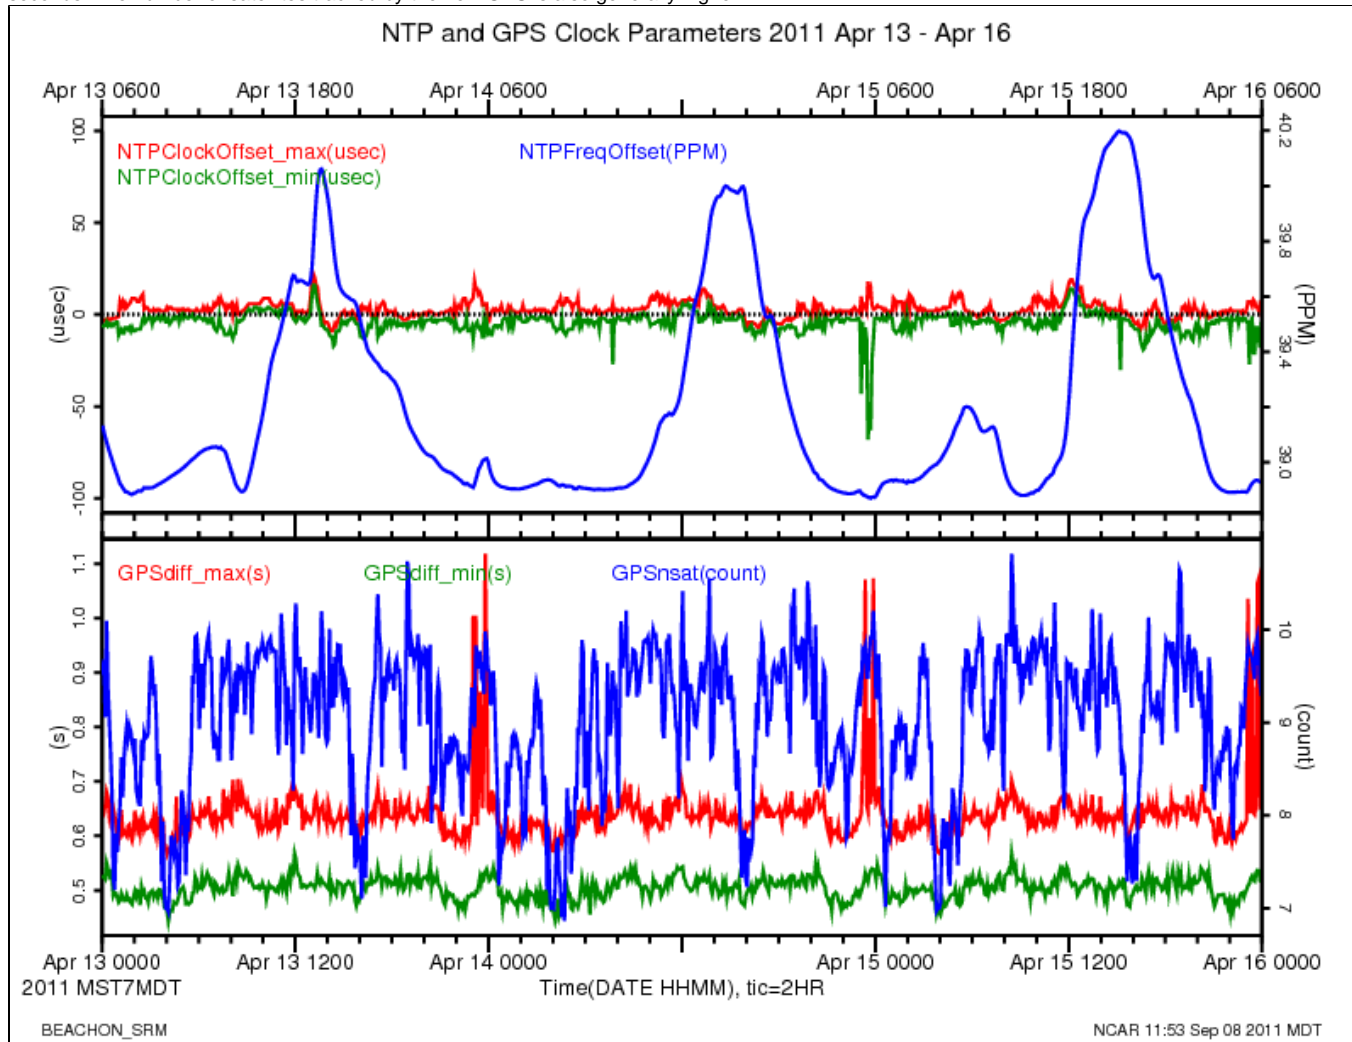
After installing 18x-LVC, the NTPClockOffset is in a much improved range, from -70 to 25 microseconds. NTPFreqOffset is also in a much tighter range, indicating that NTP is applying smaller corrections to the system clock. GPSdiff is also much better behaved, ranging from a minimum of 0.5 to 1.1 seconds. The number of satellites tracked by the new GPS is also generally higher.

On April 12, 2011 the old Garmin GPS 25-HVS at the tower was replaced with a newer Garmin 18x-LVC model. The model numbers are shown in the \$PGRMT messages in the archive, where the time is UTC:

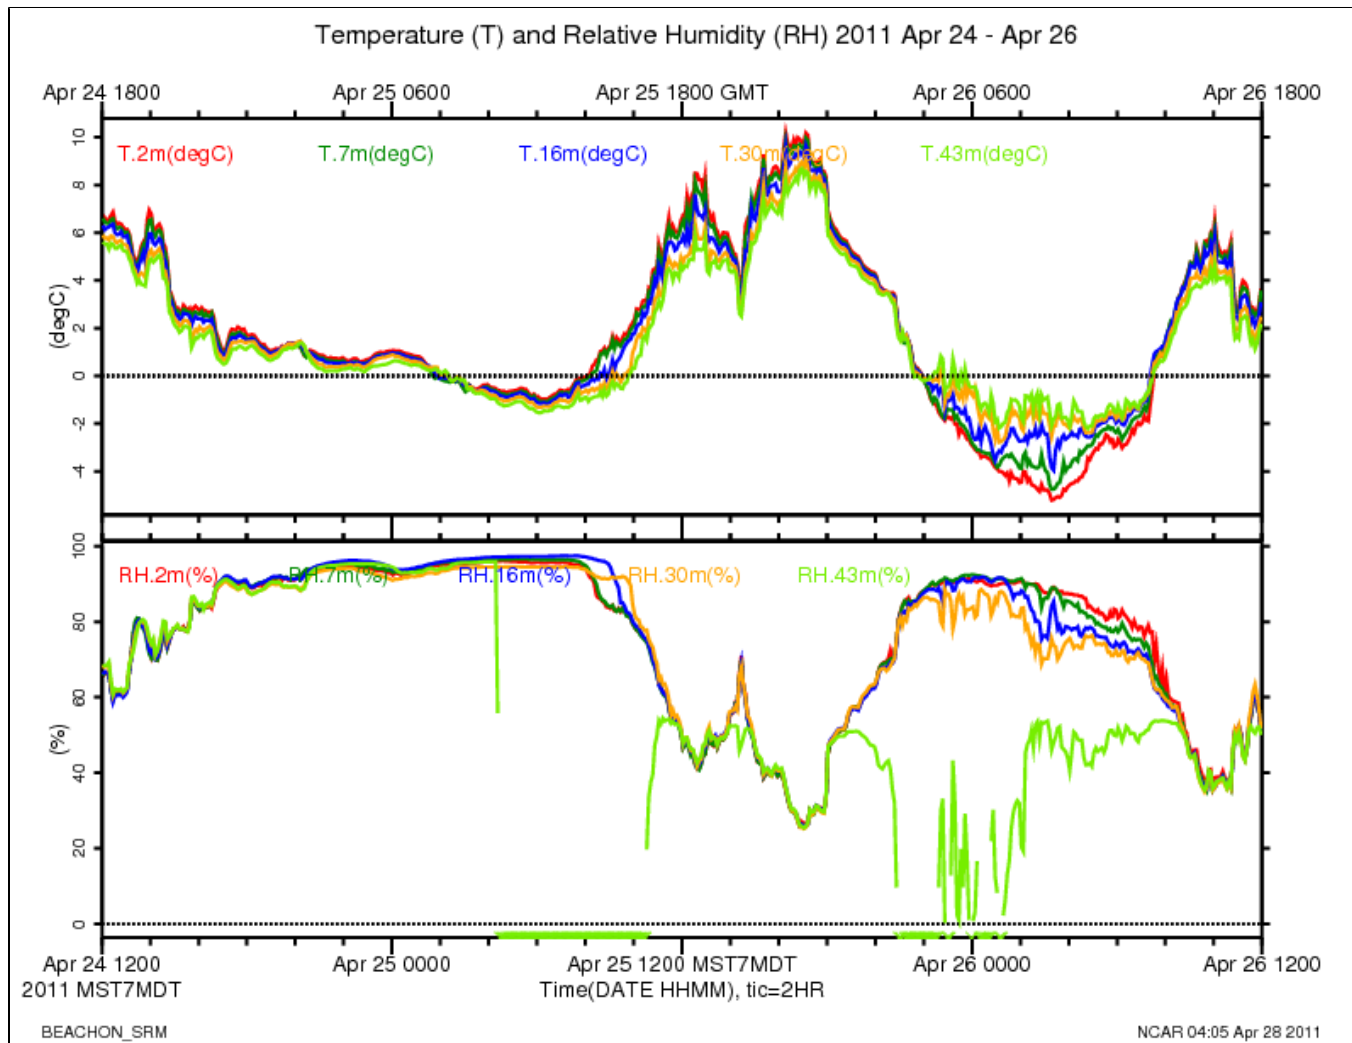
RH at 43m has been bad for a while. Looking back through the plots, looks like it failed the night of Apr 25 during a period of near 100% RH.

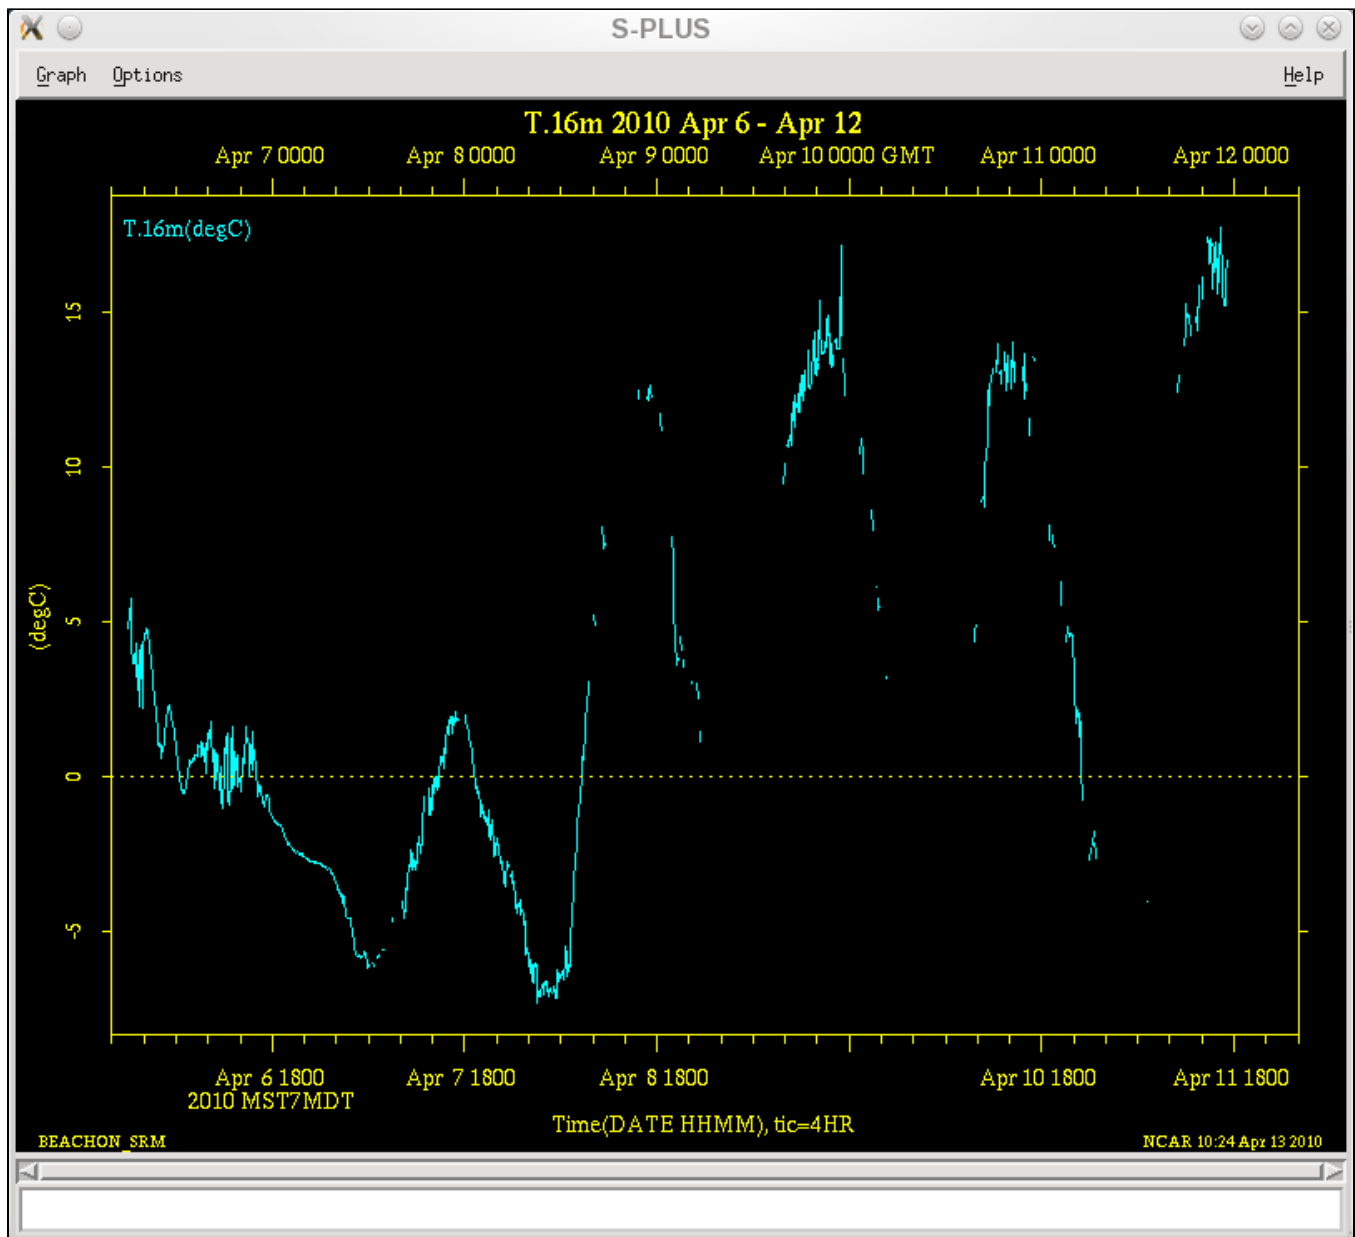
Over Apr 10,11 and 12 it seems to come alive in the warmest part of the day, (at temps over 10C) and then fails as the temp falls in the evening. See plot below.

Corroded connection?

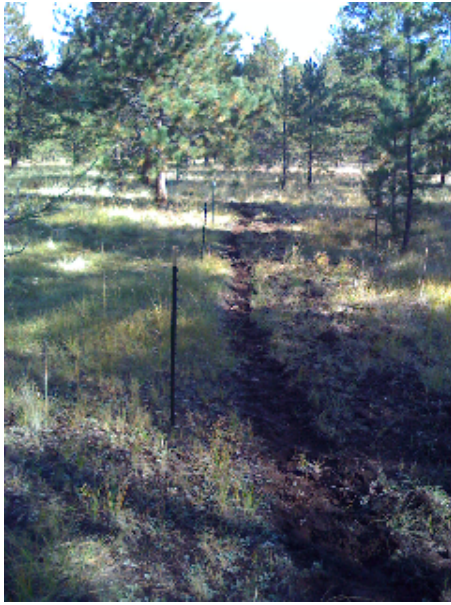
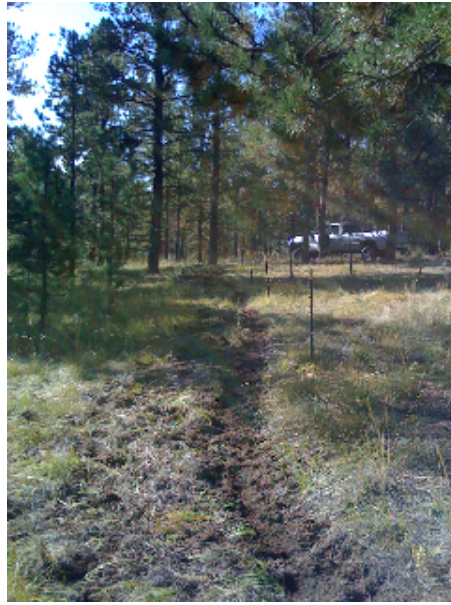
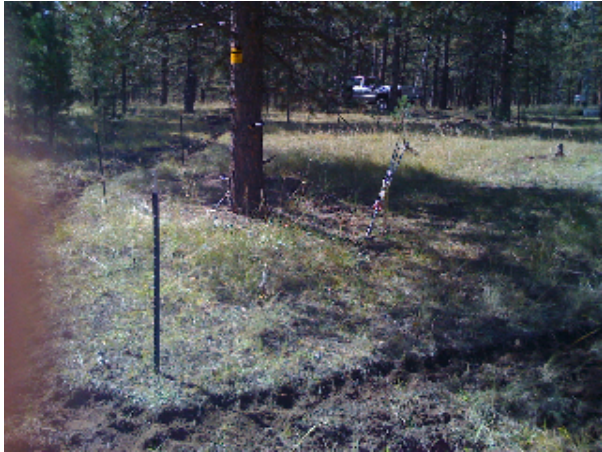
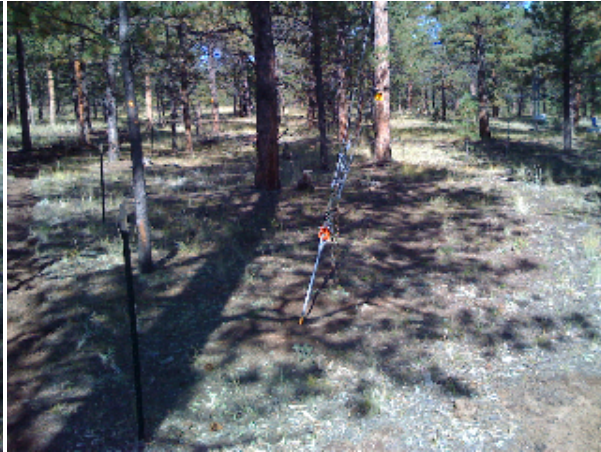
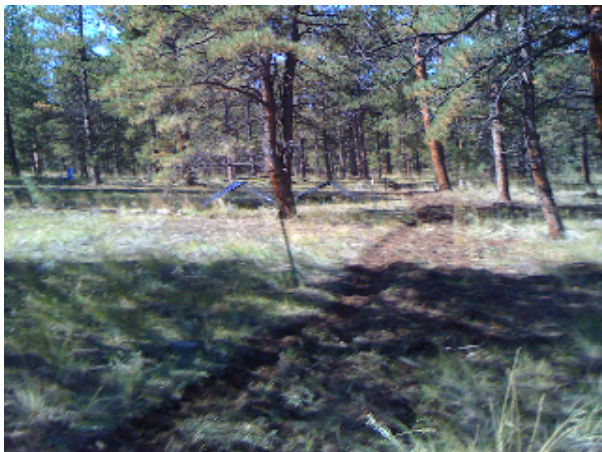
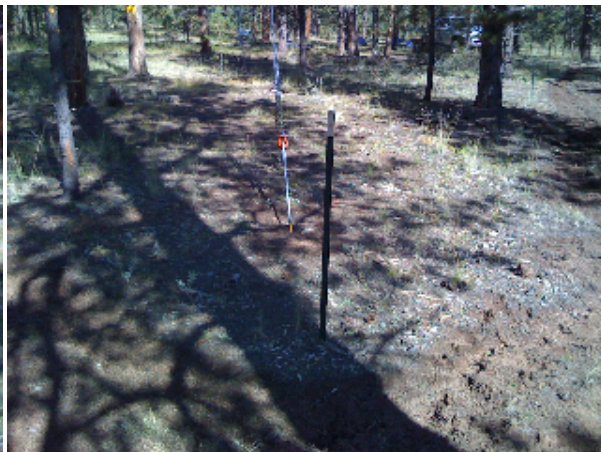
Firelines

Stopped by the 45m tower and noticed a fire line that has been scratched around the tower and anchors. The line comes about five feet from anchors and approx. seven feet from solar panels. Looked a little close if the burn gets out-of-hand. Also swapped NDAQ and beacon batteries. The batteries on beacon were around 13V while the NDAQ were at 11V. The solar panels for the NDAQ were really never in the sun while I was there (~9 - 10am) with the beacon panels were in full sunlight the whole visit time.
