# All Log Contents

[Flux tower anchor positions](#)

[Photos of dinged tower](#)

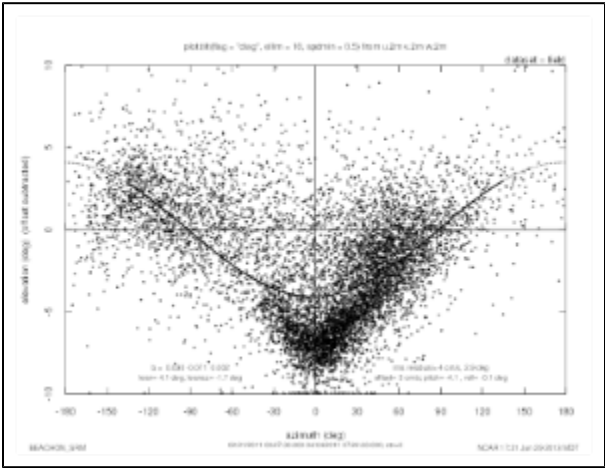
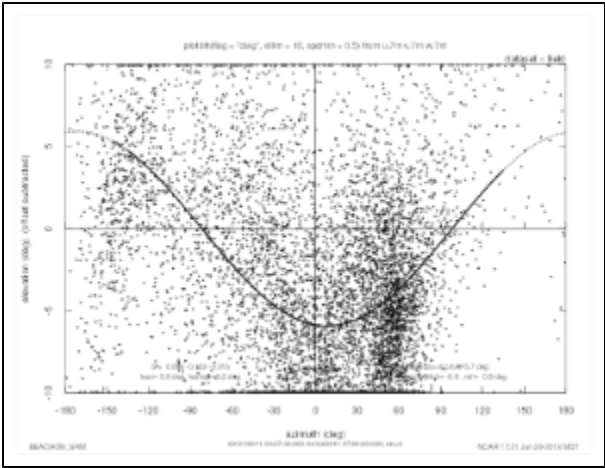
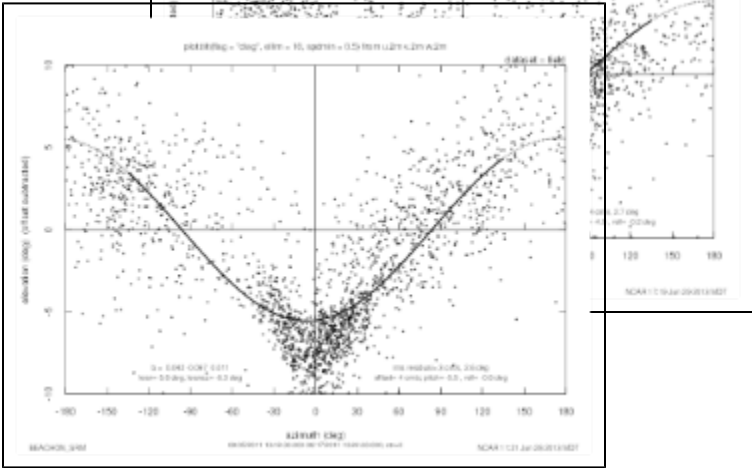
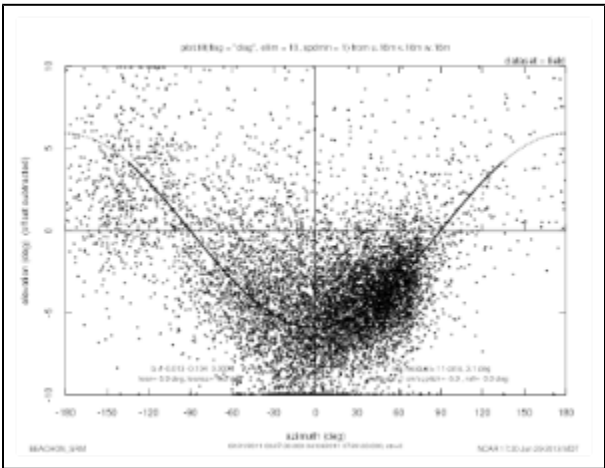
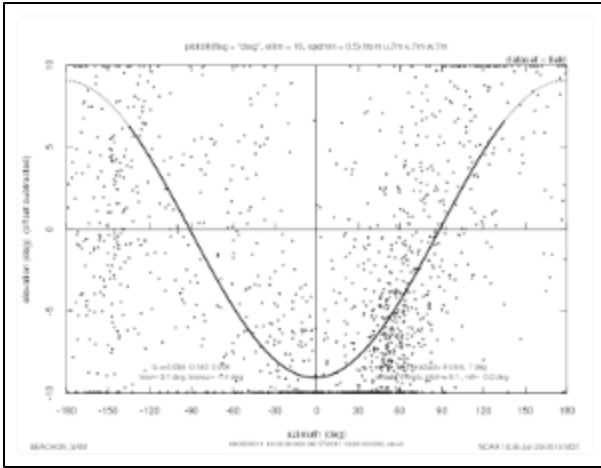
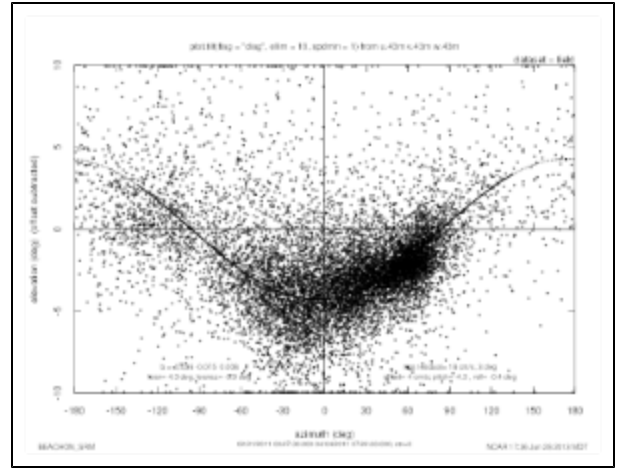
Tom says that typical droop of sonic booms results in 1 to 2 degree tilts. The sonic booms point up-slope from the tower, so the approximate 5 degree tilts seen here are a combination of the boom "droop" and the slope of the terrain.

They generally agree on an approximate 5 degree tilt of the sonics relative to the mean flow, except the 9.9 degree tilt for the 7m sonic in Aug 2011.

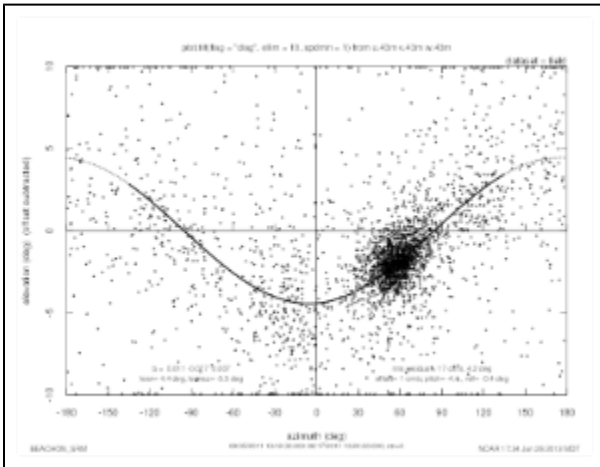
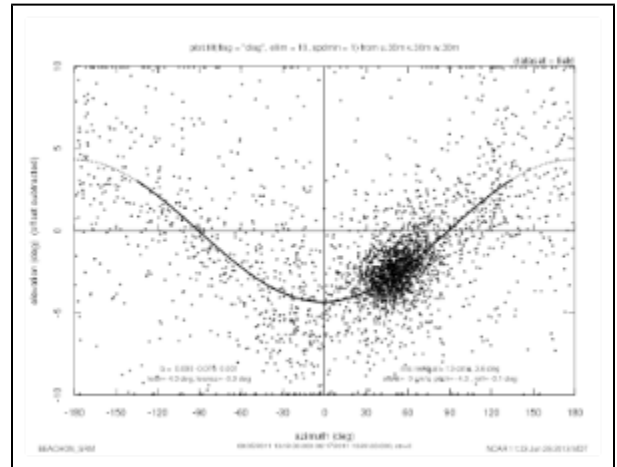
There appears to be some local "disturbance in the force", causing a pinched effect at 2 meters, and to a lesser extent at 7 meters, so that winds straight into the sonic have an additional downward inclination.

There seems to be good agreement at 16 meters and above between the two fits. I suggest using the average of the two values for those levels. Perhaps we need to look at more data for 2 and 7 meters.

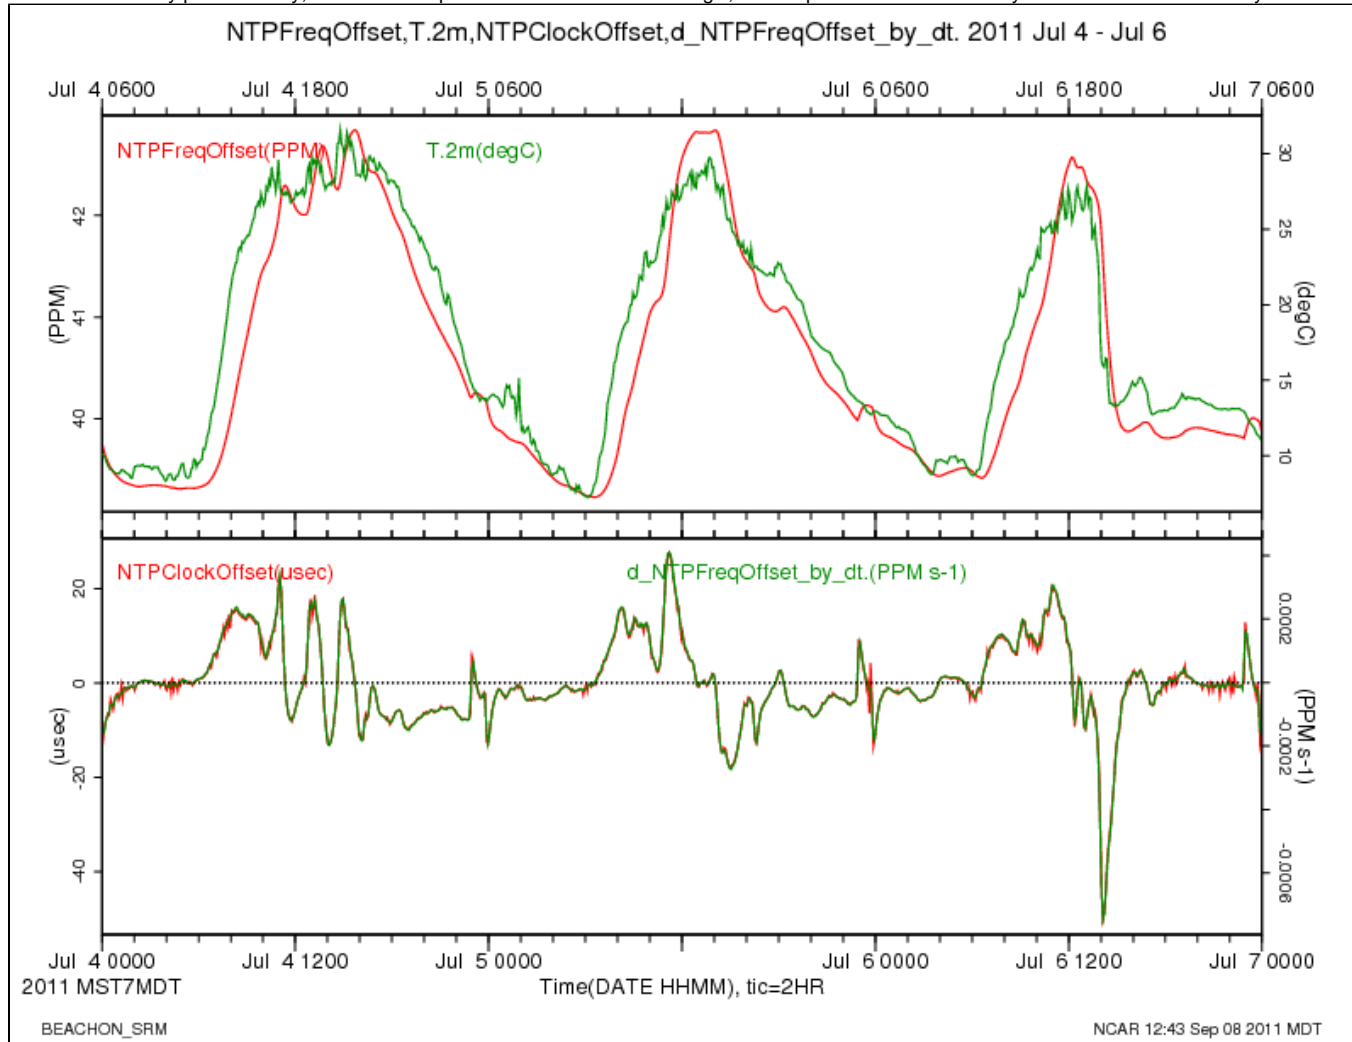
On a warmer 3 day period in July, where the temperatures were all above 5 degC, the temperature effect on the system clock oscillator is very evident.

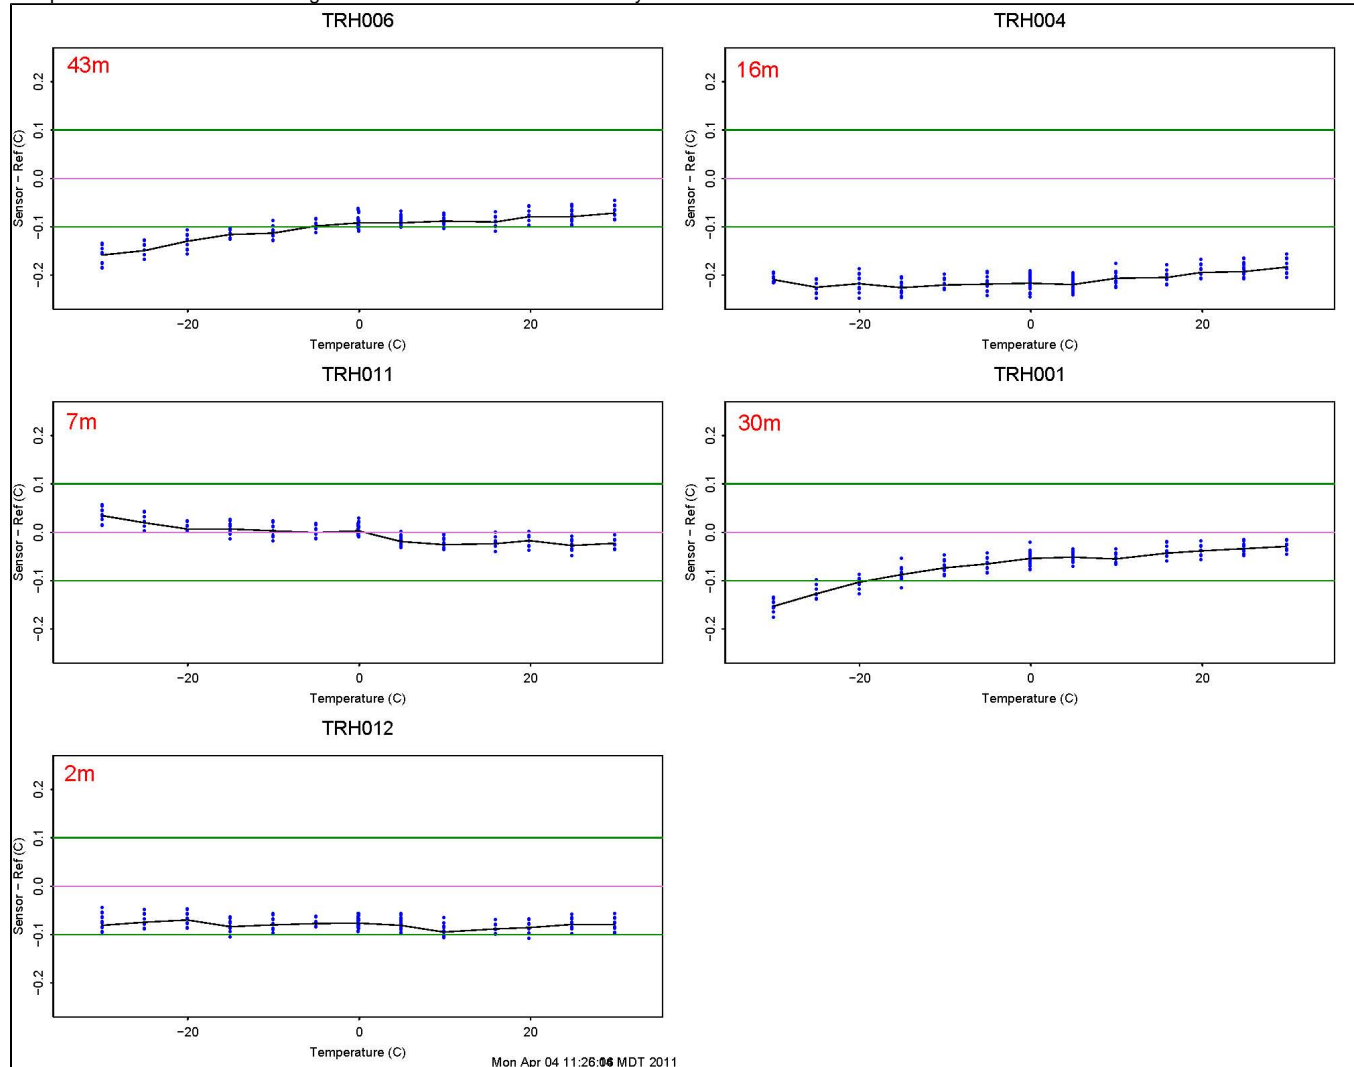
Temperature: Tested over the range of -30 to 30. It has been almost 1 year since these sensors were calibrated

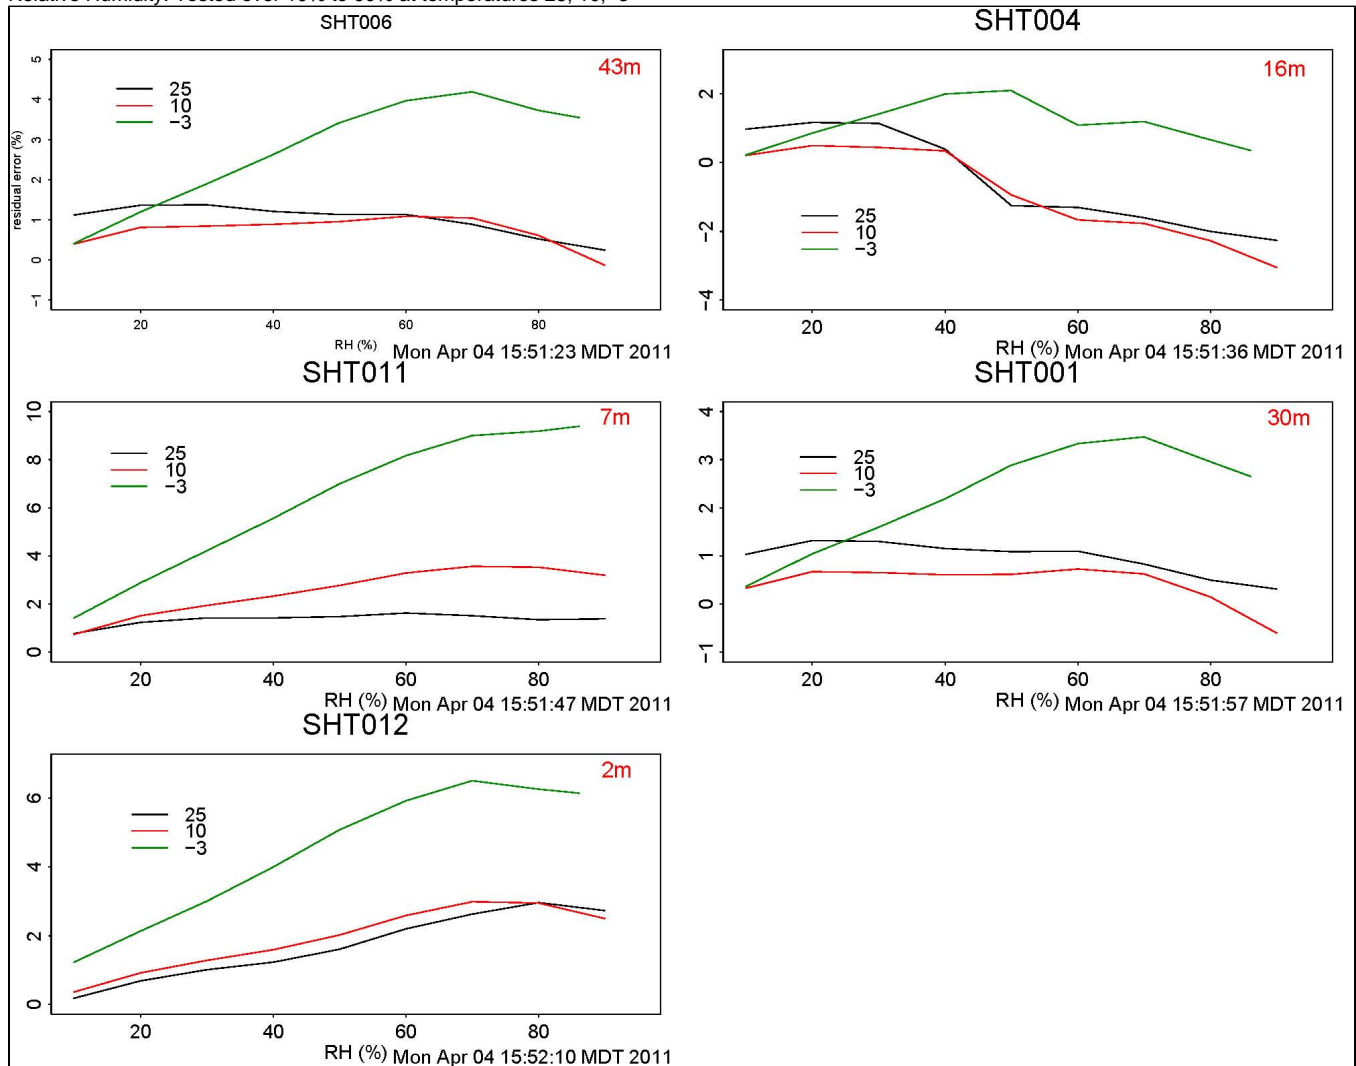
Relative Humidity: Tested over 10% to 90% at temperatures 25, 10, -3
