All Log Contents

[Flux tower anchor positions](#)

[Photos of dinged tower](#)

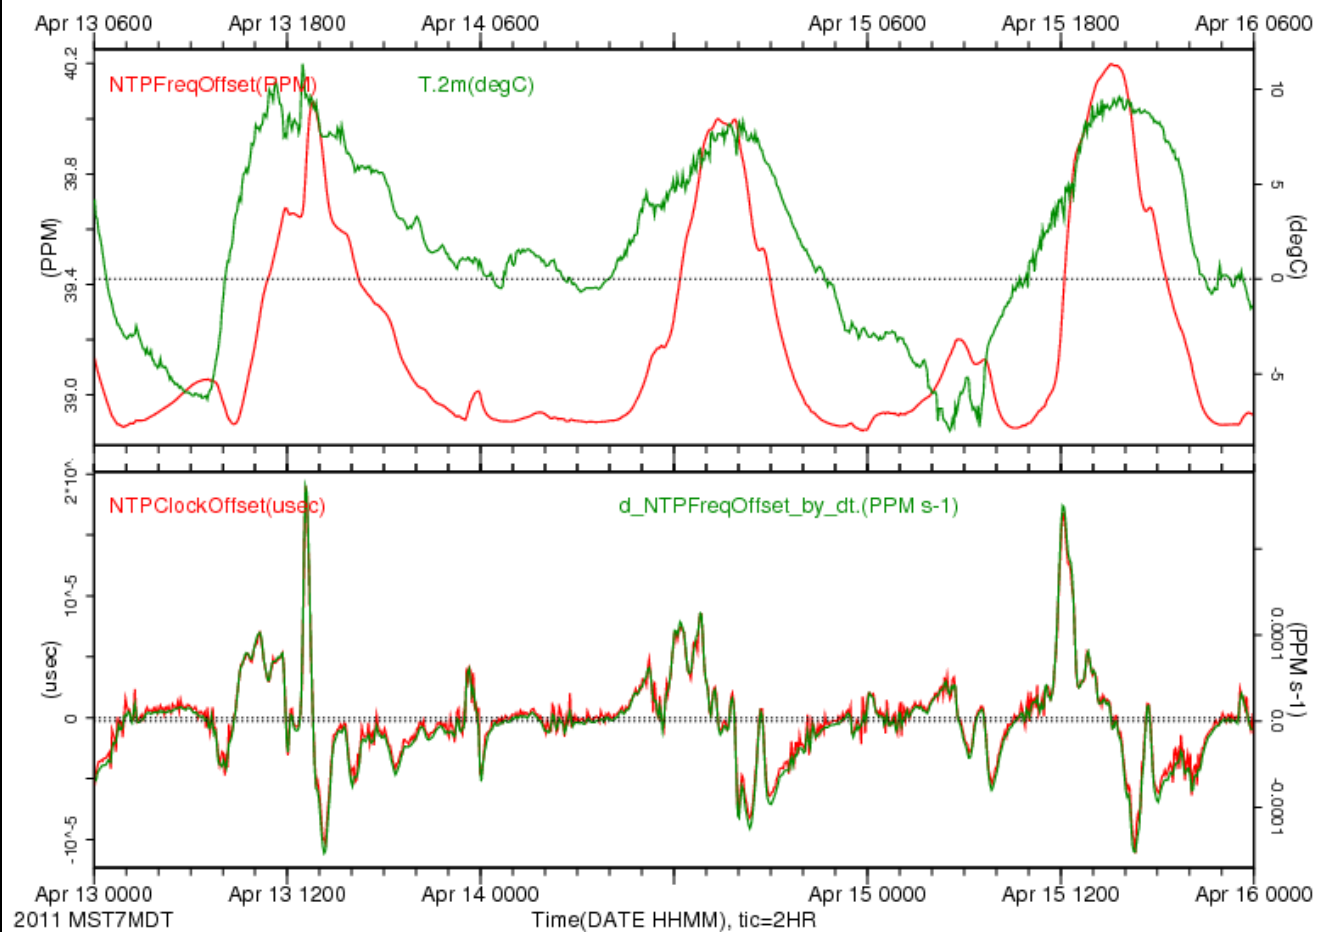
NTPFreqOffset,T.2m,NTPClockOffset,d_NTPFreqOffset_by_dt. 2011 Apr 13 - Apr 15

The NTPClockOffset shows spikes between -100000 to 50000 microseconds during this period, which is much worse than expected for a GPS/NTP reference clock. The spikes in NTPClockOffset are simultaneous with positive jumps in GPSdiff_max, up to as much as 2.5 seconds. These events seem to happen when the number of tracked satellites changes, which indicates that internal processing lags in the 25-HVS cause it to report late, causing large values of GPSdiff. The extent of this effect on the timing of the PPS signal is unknown.

The sudden downward jump in NTPClockOffset causes NTP to think that the GPS clock is earlier than the system clock. NTP starts to correct for the offset by slowing down the system clock, as seen in the negative values for NTPFreqOffset. When the GPS recovers from its delayed reporting, NTP then sees positive values for NTPClockOffset and adjusts the system clock ahead.

The bottom panel shows a close relationship between the NTPClockOffset and the time derivative of NTPFreqOffset, which, I believe, indicates how NTP adjusts the system clock based on the measured offset. It also enforces the obvious conclusion that we could improve the time-keeping by insulating the CPU from temperature changes.

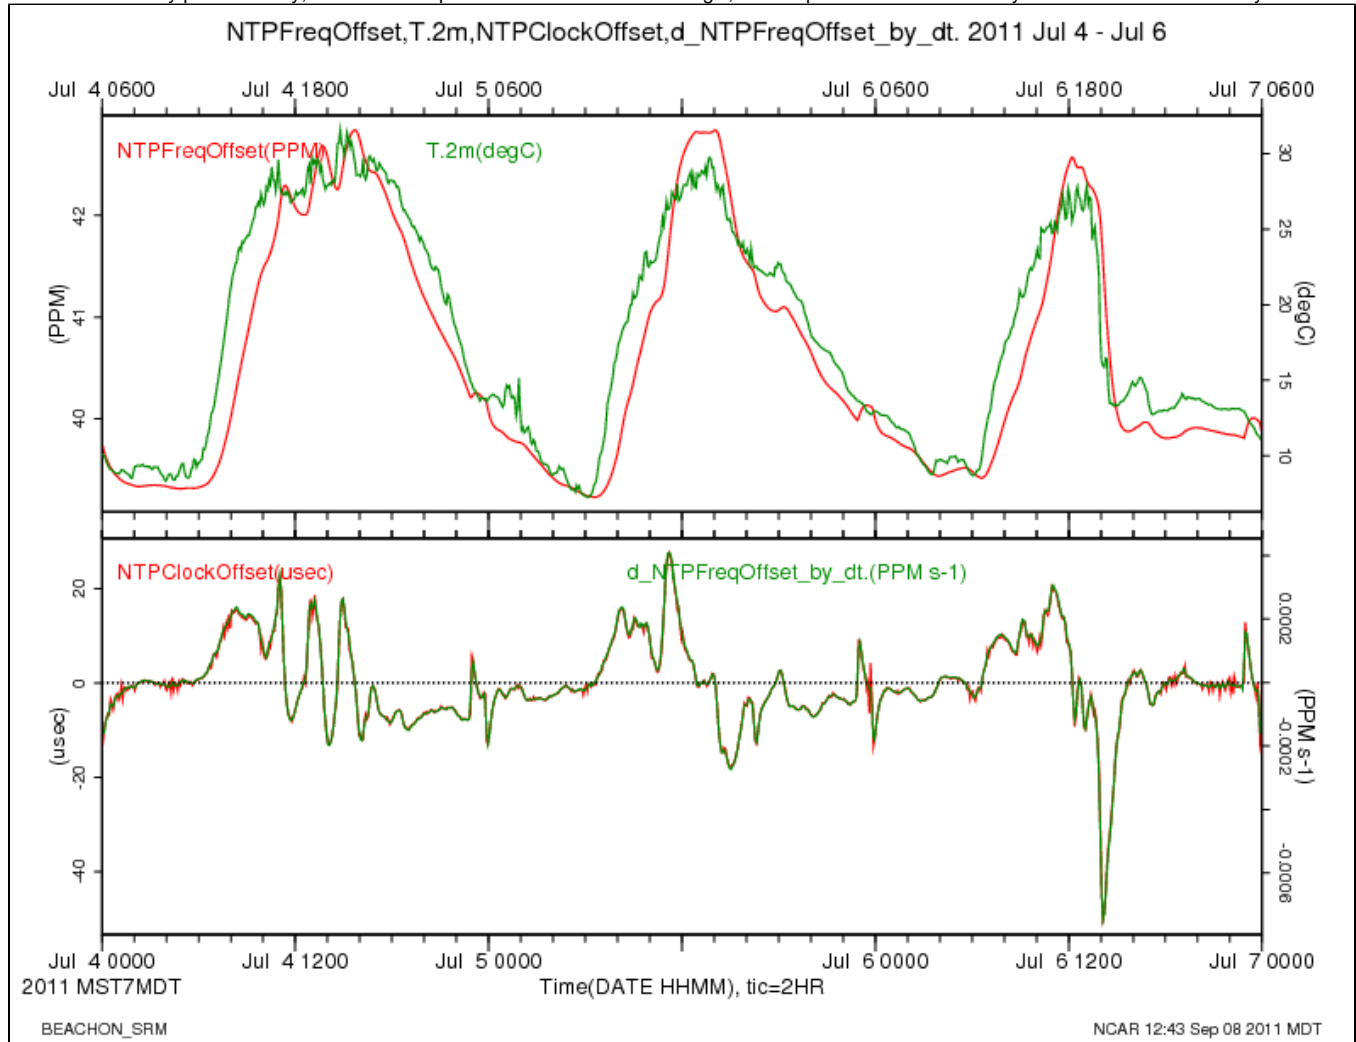
On a warmer 3 day period in July, where the temperatures were all above 5 degC, the temperature effect on the system clock oscillator is very evident.

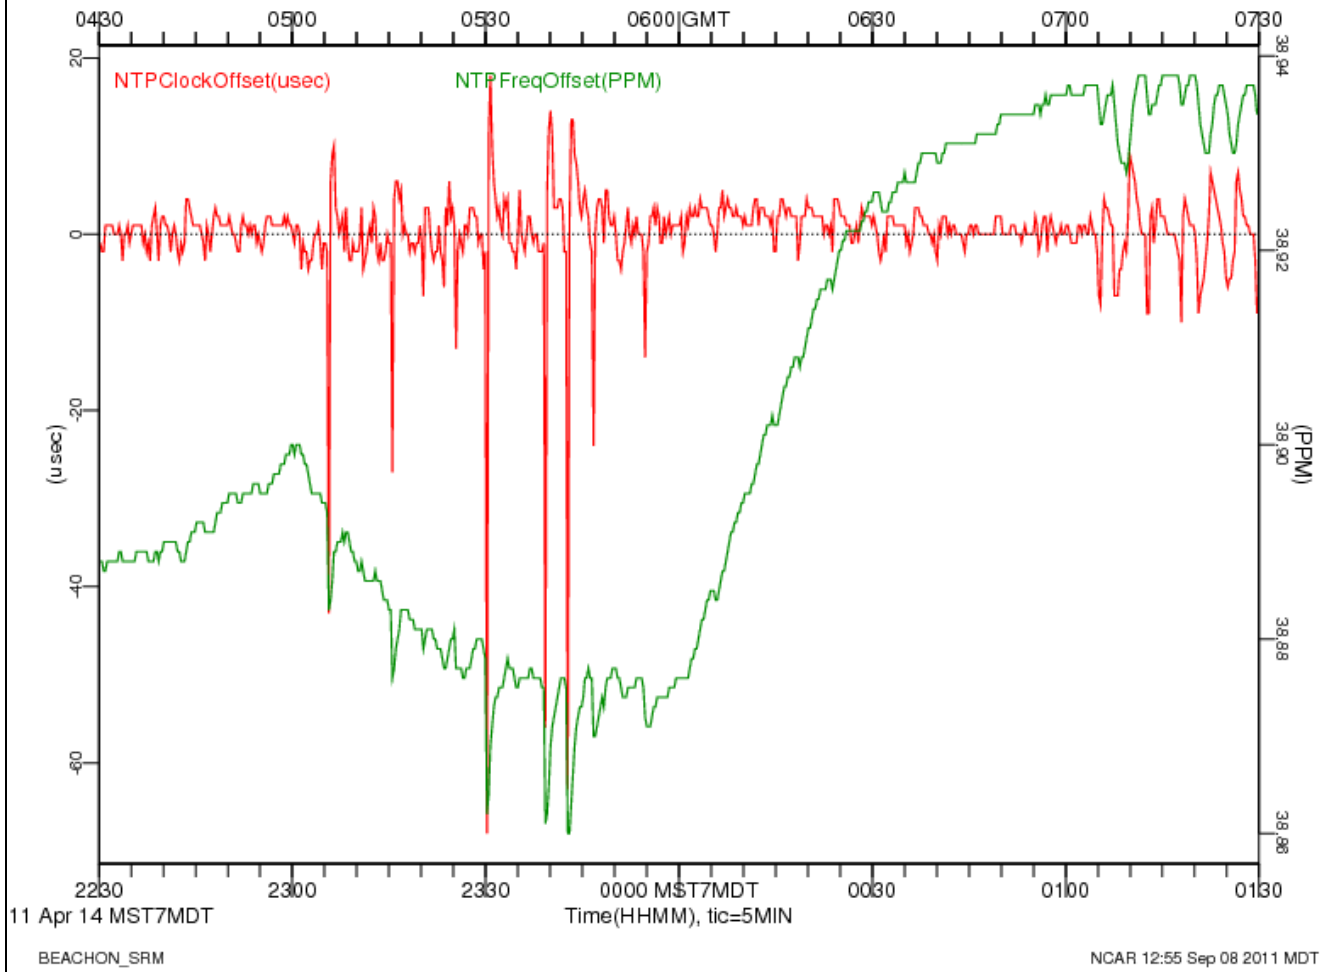
NTPClockOffset,NTPFreqOffset 2011 Apr 14 - Apr 15

The periodic spikes in GPSdiff_max up to 1 second that occur at 23:00 local time and last about an hour, are simultaneous with the network transfer of the day's data files from the DSM to the RAL server. These suggest that increased sample buffering and latency is happening at these times, which needs to be investigated and improved.

A close-up of the file transfer on April 14, 23:00, plotted below, shows several events where NTPClockOffset first has a negative spike, indicating that NTP has determined that the GPS clock is behind the system clock and starts to slow down the system clock. These down spikes appear to be due to a delay in the response to a PPS interrupt. The interrupt latency appears to be short lived, because the NTPClockOffset becomes positive, and the system clock is re-adjusted. The April 14 transfer is shown in this plot:

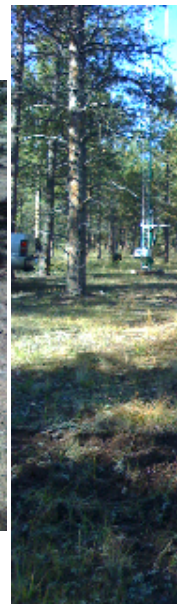
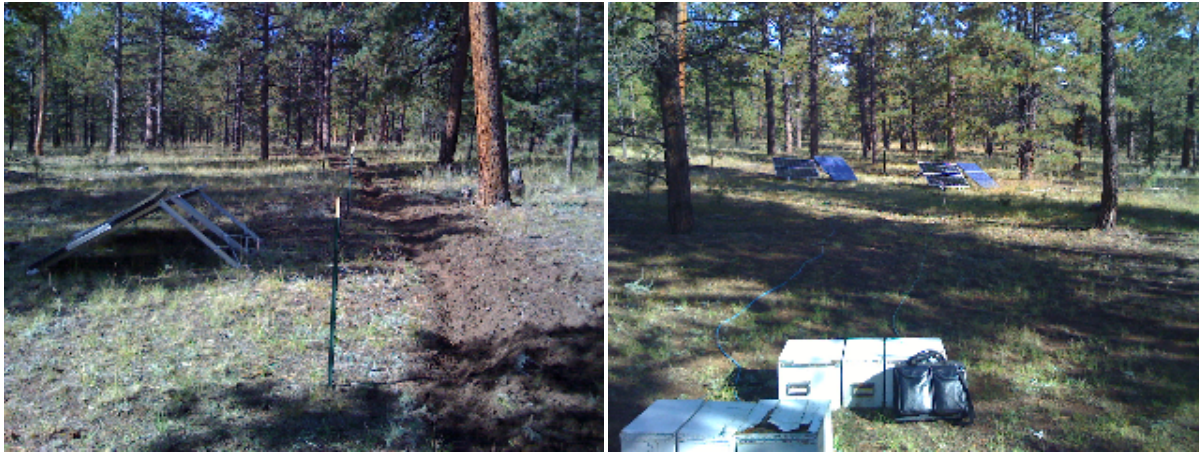
Firelines

Stopped by the 45m tower and noticed a fire line that has been scratched around the tower and anchors. The line comes about five feet from anchors and approx. seven feet from solar panels. Looked a little close if the burn gets out-of-hand. Also swapped NDAQ and beacon batteries. The batteries on beacon were around 13V while the NDAQ were at 11V. The solar panels for the NDAQ were really never in the sun while I was there (~9 - 10am) with the beacon panels were in full sunlight the whole visit time.
